## Shattered Rim and Shelling of High-Speed Railway Wheels in The Very-High-Cycle Fatigue Regime Under Rolling Contact Loading

*Engineering Failure Analysis*, Vol. 97 (March 2019): 556-567. [DOI](#). This article is © Elsevier and permission has been granted for this version to appear in [e-Publications@Marquette](#). Elsevier does not grant permission for this article to be further copied/distributed or hosted elsewhere without the express permission from Elsevier.

Due to the improvement of the wear property, rolling contact fatigue including shattered rim and shelling are the main failure causes of the high-speed railway wheels. In this paper, shattered rim and shelling occurred on the service wheels of the China Railway High-speed (CRH) trains were systematically investigated. The recorded data of the last ten years CRH operation indicated that all shattered rims and shelling were detected with serving  $>10^6$  km (corresponding to the fatigue life  $10^7$ – $10^9$  cycles) which is very-high-cycle fatigue (VHCF). The crack initiation region of shattered rim located at the depth of 10–25 mm from the tread, while that of shelling located at the depth  $<10$  mm from the tread.

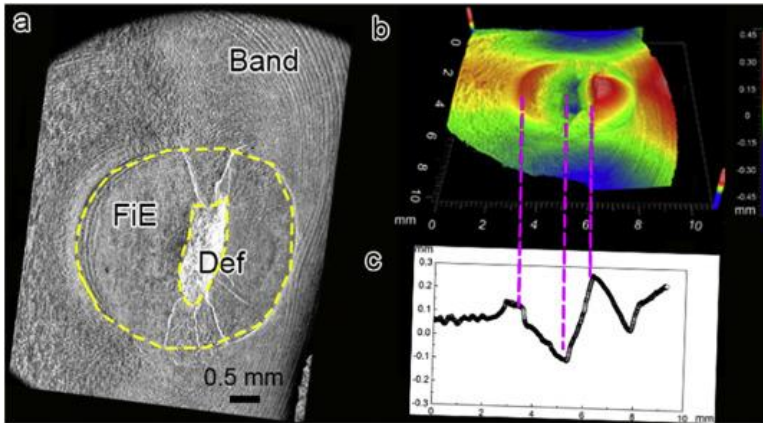
The fracture surface of shattered rims was observed by the scanning electron microscope (SEM) and 3 Dimensional Confocal MicroscopePhase Shift MicroXAM. Fig. 8a presents the SEM results, indicating three typical region with different morphology, i.e., the defect (Def), Fish-eye (FiE), and crack propagation region with beach marks (Band). Fig. 8b and c presents the 3D shape of the fracture surface. The defect, the fish-eye and the crack propagation region are not on the same plane. It can be seen from Fig. 8c that the defect and fish-eye have a height difference of about 0.4 mm. This is different from previously reported fracture surfaces of VHCF in uniaxial loading [23], where the defect, fish-eye, and crack propagation region all lie on the same plane.

Fig. 8. Fracture surface morphology by SEM and phase shift microXAM-3D, (a) 2D, (b) 3D and (c) fluctuate in the profile.

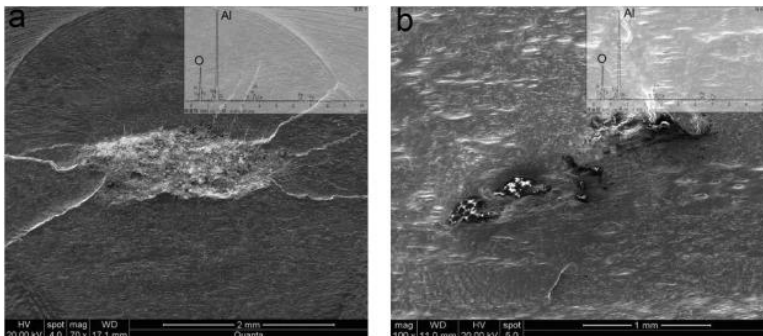
For shattered rims, rolling contact loading is applied on the wheels, which is multi-axial stress state. Due to the large confining pressures under the contact which normally suppresses any Mode I deformation of the crack, the crack propagates mainly in a mixed Mode II-Mode III [7]. In general, the Mode II-Mode III crack presents the three dimensional characteristics. The beach band in the crack propagation region is another unique feature of the VHCF under rolling contact loading. The essentially uniform equidistance distribution of beach bands indicated that the crack propagation rate is constant which is different from the rapid propagation for the case of uniaxial loading. Although FGA is the typical feature in the crack initiation region for VHCF under uniaxial loading [24], FGA was not observed around the defect for the case of rolling contact loading (Fig. 8a). Fig. 9 presents the defects for the shattered rims, including one defect type and defect cluster type. The results by energy dispersive spectrum analysis (EDS) indicate that the defects are aluminium oxide as shown in the insets of Fig. 9. Calcium oxide was also observed in other shattered rims. Defect type, size and location play an important role in the VHCF of steels [25,26]. Therefore, the VHCF under rolling contact loading demonstrates some typical features of VHCF under uniaxial loading, but also shows some distinct characteristics.

Fig. 9. Defects for the shattered rims, (a) one defect, and (b) defect cluster, Insets showing the EDS results of the defects.
