*Engineering Failure Analysis*, Vol. 97 (March 2019): 556-567. [DOI](#). This article is © Elsevier and permission has been granted for this version to appear in [e-Publications@Marquette](#). Elsevier does not grant permission for this article to be further copied/distributed or hosted elsewhere without the express permission from Elsevier.

# Shattered Rim and Shelling of High-Speed Railway Wheels in The Very-High-Cycle Fatigue Regime Under Rolling Contact Loading

## Abstract

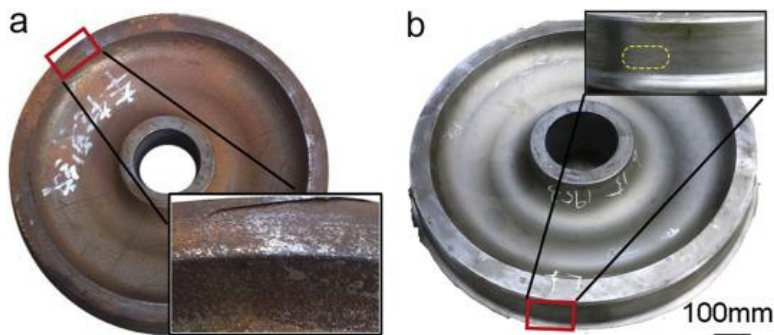
Four railway wheels (two with shattered rims and two with shelling) were removed from the CRH for further investigation. It is worth noting that shelling in this paper refer to the subsurface defect induced failure. Fig. 1 shows two removed shattered rims on CRH rail vehicles. A crack was observed on the rim which has extended to the tread as shown in Fig. 1a, called penetrating shattered rim. No crack was observed on the tread and rim of the wheel as shown in Fig. 1b. However, a crack was detected by ultrasonic detection, which called non-penetrating shattered rim. The non-penetrating shattered rim will extend to the rim with further service. Fig. 2 presents two typical shelling on the CRH wheels that caused the failure of wheels. The ultrasonic detection was applied to detect the crack under the tread. A crack with the area of  $30\text{ mm} \times 30\text{ mm}$  was detected in the wheel (Fig. 2a), and the location is 3 mm depth from the tread. The wheel in Fig. 2b also contained a crack with the area of  $8\text{ mm} \times 20\text{ mm}$ , and the location is about 4 mm depth from the tread surface.

Fig. 1. Photographs taken from CRH wheels showing (a) penetrating, and (b) non-penetrating shattered rims.

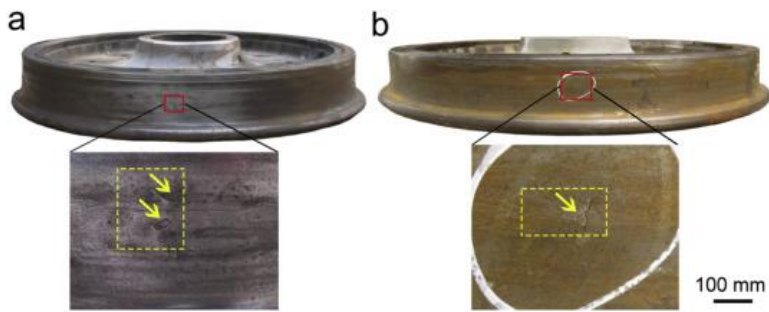
Fig. 2. Photographs taken from CRH wheels showing (a) multipoints, and (b) single point shelling.

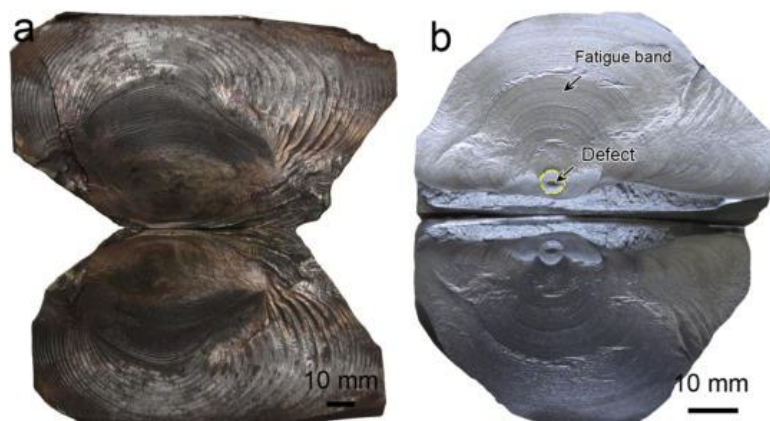
Fig. 7 presents the opening crack surfaces of the shattered rims. Fig. 7a is the crack surfaces of the penetrating shattered rim corresponding to the wheel in Fig. 1a. Although the crack surfaces have been contaminated due to oxidation and the crack initiation region is slightly blurred due to the corrosion, it is clear that the crack initiated and fatigue fractured from interior of the wheel. Fig. 7b is the non-penetrating shattered rim surfaces corresponding to the wheel in Fig. 1b. The crack surface is fresh and clear which is helpful for the investigation of crack initiation mechanism. The crack initiation region contains a defect surrounding with a flat region marked by dot line. Abundant beach bands were located in the crack growth region.

Fig. 7. Shattered rim surfaces, (a) penetrating, and (b) non-penetrating.

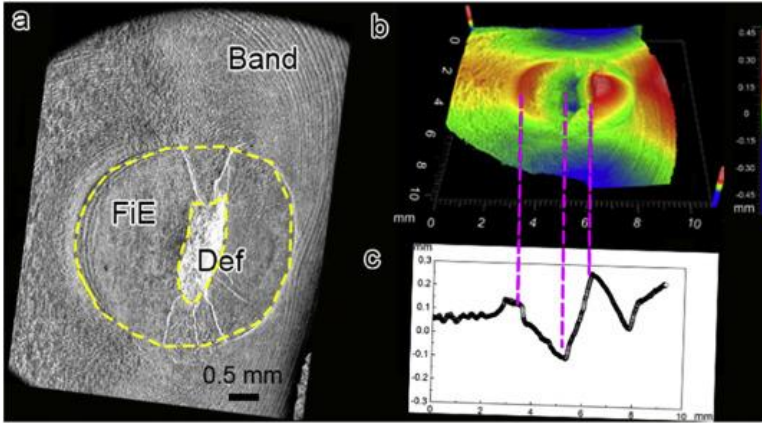
The fracture surface of shattered rims was observed by the scanning electron microscope (SEM) and 3 Dimensional Confocal MicroscopePhase Shift MicroXAM. Fig. 8a presents the SEM results, indicating three typical region with different morphology, i.e., the defect (Def), Fish-eye (FiE), and crack propagation region with beach marks (Band). Fig. 8b and c presents the 3D shape of the fracture surface. The defect, the fish-eye and the crack propagation region are not on the same plane. It can be seen from Fig. 8c that the defect and fish-eye have a height difference of about 0.4 mm. This is different from previously reported fracture surfaces of VHCF in uniaxial loading [23], where the defect, fish-eye, and crack propagation region all lie on the same plane.

Fig. 8. Fracture surface morphology by SEM and phase shift microXAM-3D, (a) 2D, (b) 3D and (c) fluctuate in the profile.

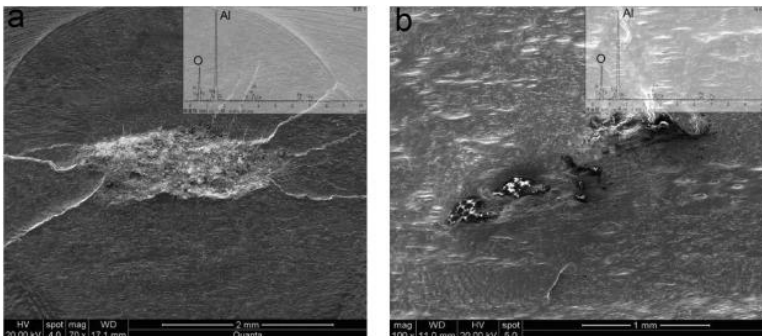
For shattered rims, rolling contact loading is applied on the wheels, which is multi-axial stress state. Due to the large confining pressures under the contact which normally suppresses any Mode I deformation of the crack, the crack propagates mainly in a mixed Mode II-Mode III [7]. In general, the Mode II-Mode III crack presents the three dimensional characteristics. The beach band in the crack propagation region is another unique feature of the VHCF under rolling contact loading. The essentially uniform equidistance distribution of beach bands indicated that the crack propagation rate is constant which is different from the rapid propagation for the case of uniaxial loading. Although FGA is the typical feature in the crack initiation region for VHCF under uniaxial loading [24], FGA was not observed around the defect for the case of rolling contact loading (Fig. 8a). Fig. 9 presents the defects for the shattered rims, including one defect type and defect cluster type. The results by energy dispersive spectrum analysis (EDS) indicate that the defects are aluminium oxide as shown in the insets of Fig. 9. Calcium oxide was also observed in other shattered rims. Defect type, size and location play an important role in the VHCF of steels [25,26]. Therefore, the VHCF under rolling contact loading demonstrates some typical features of VHCF under uniaxial loading, but also shows some distinct characteristics.

Fig. 9. Defects for the shattered rims, (a) one defect, and (b) defect cluster, Insets showing the EDS results of the defects.

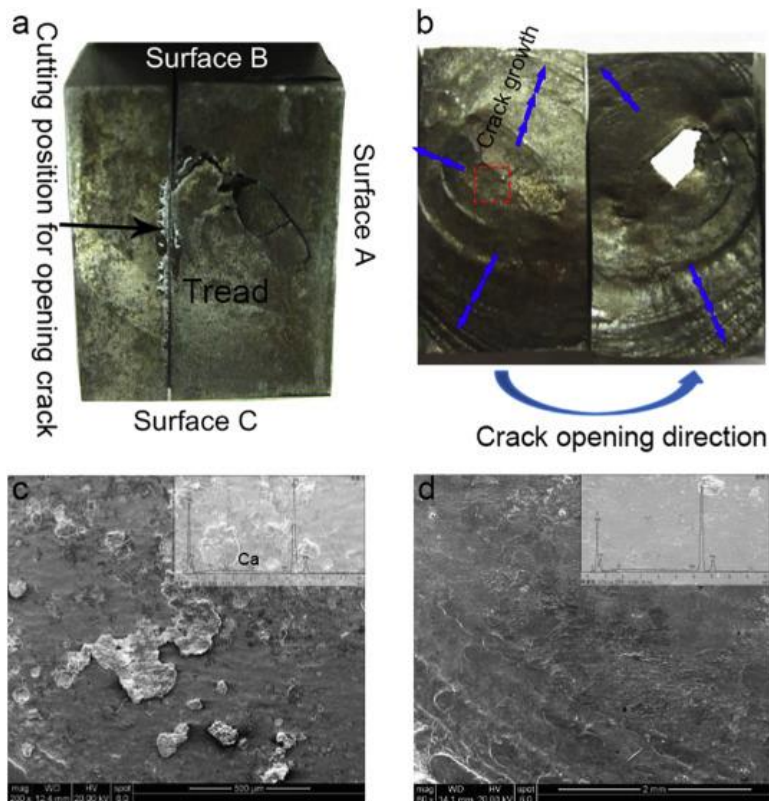
Fig. 10a presents the sample containing the shelling crack cut from the wheel shown in Fig. 2b. Surfaces A, B and C are prepared for crack and microstructure observations. The cutting position on the tread was marked by the arrow for opening the crack. The opening crack surfaces are presented in Fig. 10b. The crack surfaces were somewhat corroded and extruded, but the fatigue fracture features were evident. It is worth noting that part of the crack surface was missing due to wearing. The crack initiation site can be distinguished (Marked by the red box). The morphology is similar with that in Fig. 8, which can be regarded as the same fatigue behavior. Fig. 10c presents the crack initiation site observed by SEM. Defect was found in this region which were confirmed by EDS. Fig. 9d presents the crack propagation region. Beach bands were observed in this region.

Fig. 10. Observations of the opening crack surface, (a) sample cut from the wheel, (b) opening crack surface, (c) crack initiation site by SEM, and (d) crack propagate region.

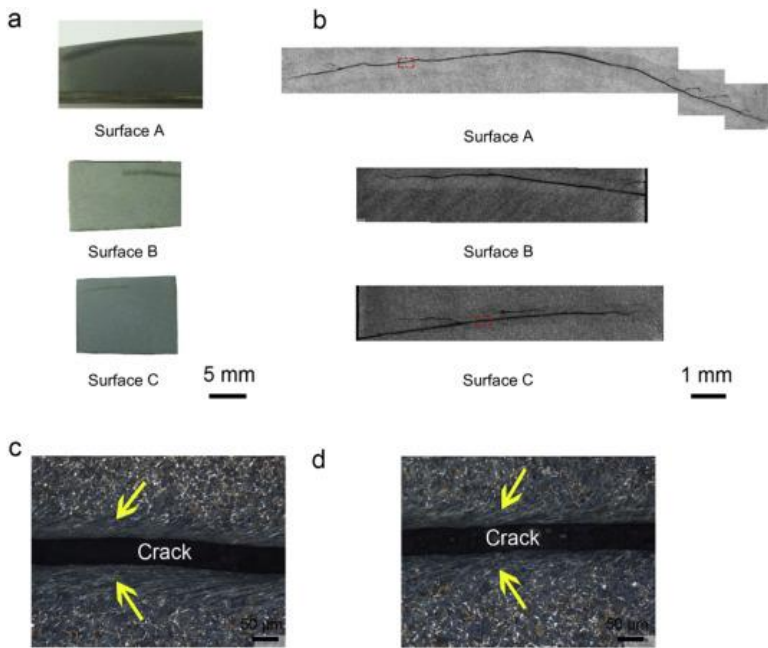
Fig. 11a presents the three surfaces prepared for observations. Surface A contains a 19 mm length crack, and the deepest location of the crack is about 2.3 mm. The crack in Surface B is 7.7 mm in length, and that in Surface C is also 7.7 mm. The deepest locations are 2 mm and 2.3 mm respectively. Fig. 11b presents the morphology of the crack, indicating that the crack growth direction is almost parallel to the tread. Second cracks were observed for all the cases, which is related to the rolling contact loading. Fig. 11c and d present the microstructure around the cracks. A shear plastic deformation microstructure layer with 70 μm thickness (marked by arrows) was observed around the crack, which supported that the crack is driven by shear stress.

Fig. 11. Observations of the cracks and microstructure, (a) metallographic observation surface A, B and C, (b) Cracks in Surface A, B and C, (c) and (d) microstructure around the cracks.

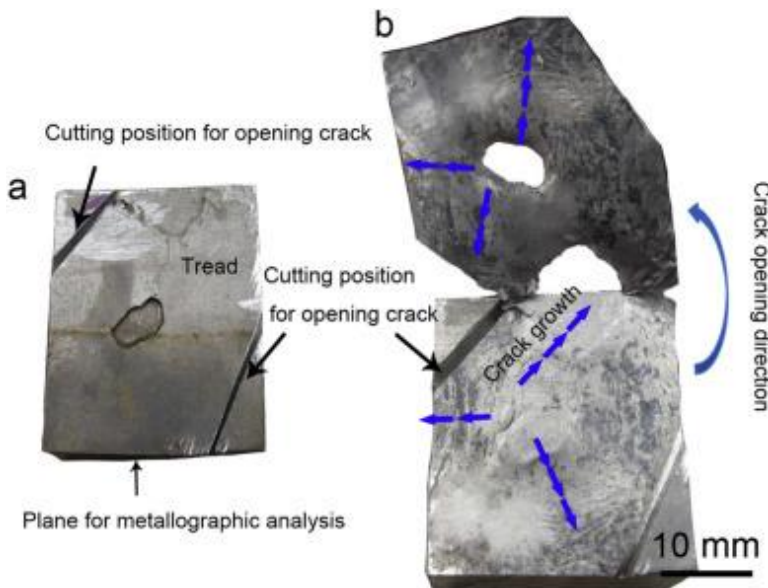
Fig. 12a presents another sample containing the shelling crack cut from the wheel in Fig. 2a. The cutting position on the tread was marked by the arrows for opening the crack. A surface was prepared for crack and microstructure observations which were presented in Fig. 12. The opening crack surfaces are presented in Fig. 12b. It is indicated that fatigue fracture characteristics were presented although the crack surfaces were corroded and extruded. Shelling occurred on the crack surface of tread. Fig. 13a presents the metallographic surface prepared for observations. The service load of the wheels is rolling contact, which causes plastic deformation (marked by arrows) on the tread as shown in Fig. 13b. The grain refinement occurred in the tread, and the grain size increases gradually with an increasing depth. The microstructures around the cracks near tread are presented in Fig. 13c and d, indicating also evident grain refinement (marked by arrows).

Fig. 12. Observations of the opening crack surface, (a) sample cut from the wheel, (b) opening crack surface.

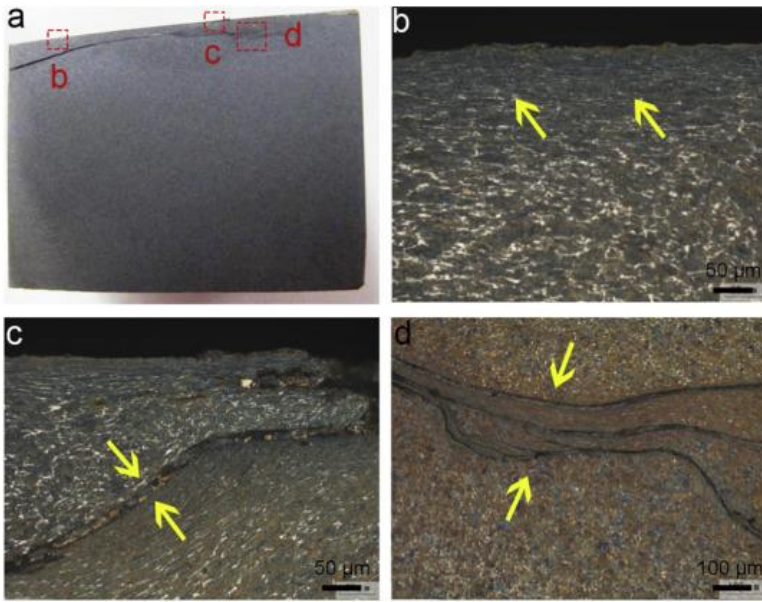
Fig. 13. Observations of the cracks and microstructure, (a) metallographic surface, (b) microstructure on the tread, (c) and (d) microstructure around the cracks.
