## Lessons Learned from an Emergency Bridge Replacement Project

# Lessons Learned from an Emergency Bridge Replacement Project

component of the nation's transportation network, in case they are damaged or destroyed by extreme events. One of the tasks associated with this research was to conduct case studies of previous bridge replacements following extreme events. By studying these cases, the research team sought to identify and expand on lessons learned, address which actions did and did not work well given the circumstances of the incident, and incorporate lessons into the emergency response plan for highway bridges. This paper presents the findings from one of the case studies, the I-40 Webbers Falls Bridge in Oklahoma.

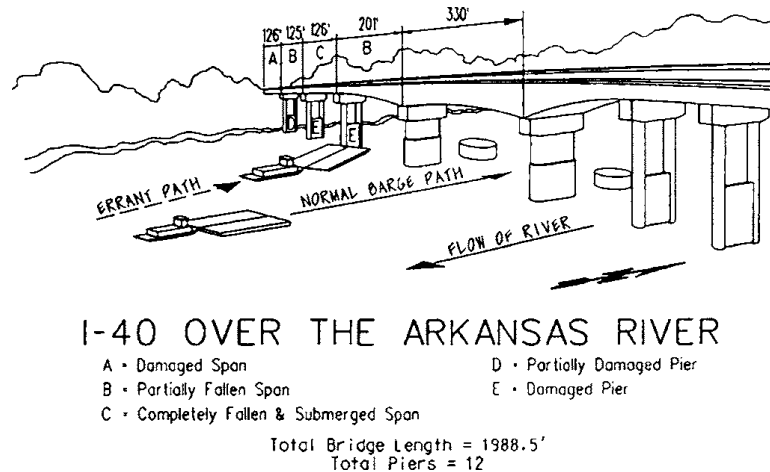
Figure 1. I-40 bridge incident sketch

The 20 m (64 ft) wide, 606 m (1988 ft) long, four-lane bridge was built in 1967 over the Arkansas River near Webbers Falls, Oklahoma ("Oklahoma" 2002). The original structure was a continuous haunched steel girder bridge with a 61–101–61 m (201–330–200 ft) main span combined with steel girder approach spans and a reinforced concrete deck. The steel girders were supported by 12 concrete piers. Fig. 1 shows the normal barge path and the errant barge path that resulted in a collision with the bridge. The barge was about 91 m (300 ft) outside the regular navigation channel (main channel) when it rammed into the unprotected piers of the bridge, knocking down two piers (indicated as E piers) and partially damaging another (indicated as the D pier). Four spans totaling approximately 152 m (500 ft) were also damaged. Span 1 [38 m (126 ft), shown as damage type A] was damaged, but did not fall. Span 2 [38 m (125 ft), shown as damage type B] and Span 4 [61 m (201 ft), shown as damage type B] partially fell into the river. Span 3 [38 m (126 ft), shown as damage type C] completely collapsed into the river. Fig. 2 shows the damaged bridge.

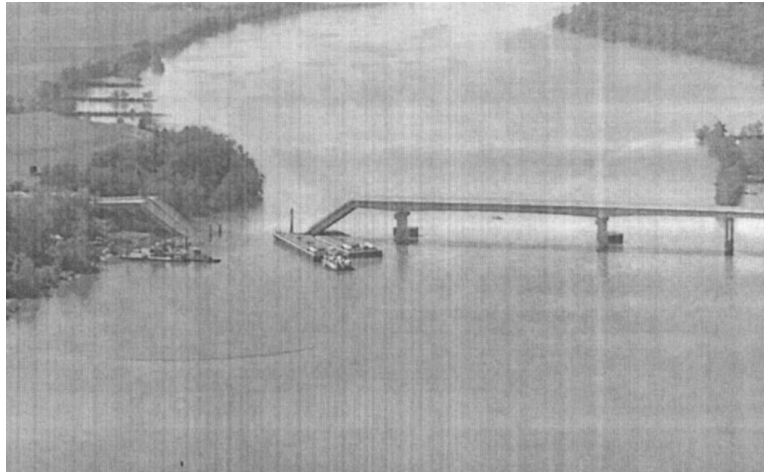
Figure 2. Overview of damaged bridge

The demolition crews knocked down the remaining piers first, and then began breaking up the concrete on the spans. Spans 1 and 2 were brought down using explosives, and the debris was removed from the site. Span 3, which had completely fallen into the river, had to be removed using underwater demolition. The working environment for the underwater demolition was hazardous due to poor visibility. Demolition of the damaged section of Span 4 was the most challenging task. This span was partially damaged. One end rested on the barges, while the other end was still attached to the undamaged bridge, as shown in Fig. 2. The remainder of the bridge structure could have been further damaged if the crews had not been careful during the demolition. To prevent this from happening, the Magnolia Marine Transport Company stabilized the barges and the crews constantly monitored the movements of the bridge and barges. Combinations of demolition devices including a wrecking ball, explosives, concrete shears, and other cutting devices were used to meet the different needs at the site.

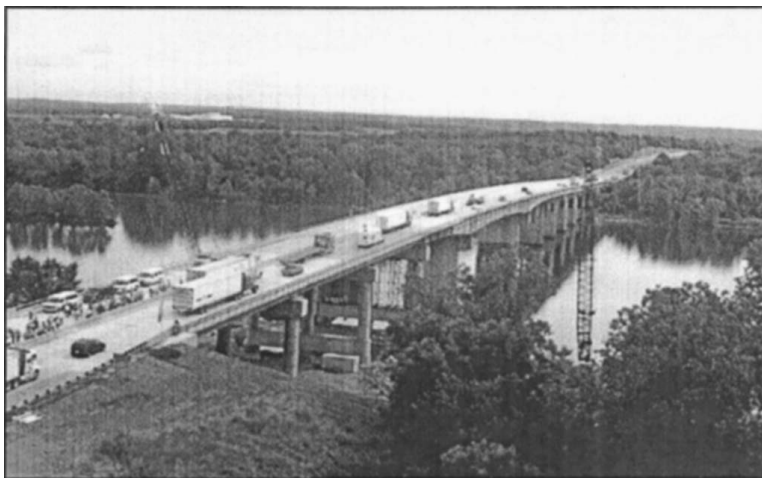
Figure 5. I-40 bridge reopened to traveling public

In addition to efforts from the construction industry, coordination among federal, state, and tribal governments was crucial to putting the bridge back into commission on the fast track. As the sole owner of the Arkansas Riverbed and banks at Webbers Falls, the Cherokee Nation controls the land around the reconstruction site. From day one, the Cherokee Nation contributed land and manpower and facilitated the project by making work areas easily accessible to the general contractor and subcontractors ("Cherokee Nation" 2002). The Federal Highway Administration (FHWA) approved \$3 million in federal emergency relief funds to get the repair work started immediately (FHWA 2002). Through the repair process, FHWA provided technical expertise and assistance to ODOT, particularly in the areas of bidding and contract administration. Both agencies worked together to streamline the bid review and approval procedures and get the reconstruction contract ready to put out for bid. ODOT also received technical help and cooperation from the U.S. Army Corps of Engineers, the U.S. Coast Guard, and other state DOTs. Fig. 5 shows the bridge as it was reopened to the traveling public on July 29, 2002.
