Cost Effective Concrete Pavement Cross Sections - Final Report

COST EFFECTIVE CONCRETE PAVEMENT CROSS SECTIONS

FINAL REPORT WI/SPR-03-05 WisDOT Highway Research Study # 95-03

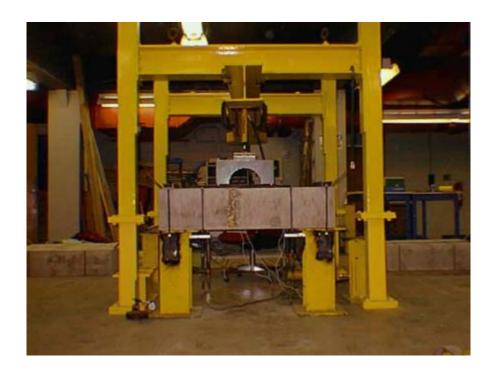
Figure 2.2.2: Joint Deflection Test Set-up

The test load was applied using a manually actuated ENERPAC hydraulic ram mounted on a steel reaction frame. The load ram was centered on the test specimen. Steel plates and arched steel blocks were positioned over the central portion of the specimen to distribute the load uniformly across the center section of the specimen. Four load cells were positioned near the corners of the arched steel block to monitor the applied load. Load cell and LVDT data were collected with a Datronic data collection system using a 2 Hz sampling rate. The load was increased at a rate of approximately 2000 lb/min until a maximum of 5000 lb was obtained. Figure 2.2.2 provides a photo of the test set-up during loading.

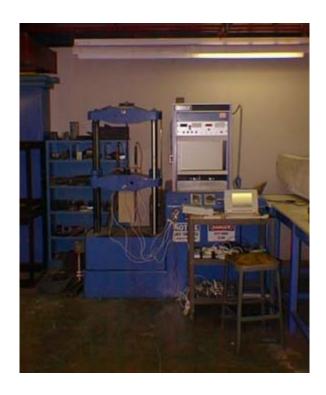
Figure 2.4.1: Modified Pull-Out Test Set-Up

Initial pull-out tests were conducted after 48 hours of concrete curing. The test specimens were then cured an additional 12 days prior to subjecting to 50 cycles of freeze-thaw in a 10% by mass sodium chloride solution. After freeze-thaw conditioning, a second pull-out test was conducted. During both test series, the data recording apparatus was modified from the initial apparatus used in the uncoated tests to allow for continuous data collection during the test. The modified apparatus utilized four load cells and two LVDTs for monitoring load and relative dowel displacement, respectively. Load cell and LVDT data were collected with a Strawberry Tree data collection system set at a 5 Hz sampling rate. Figure 2.4.1 illustrates the modified test set-up.
