# Bond–slip Behavior of Fiber-reinforced Polymer/ concrete Interface in Single Shear Pull-out and Beam Tests

Tayyebah Mohammadi  
*Marquette University*

Baolin Wan  
*Marquette University, baolin.wan@marquette.edu*

Kent A. Harries  
*University of South Carolina - Columbia*

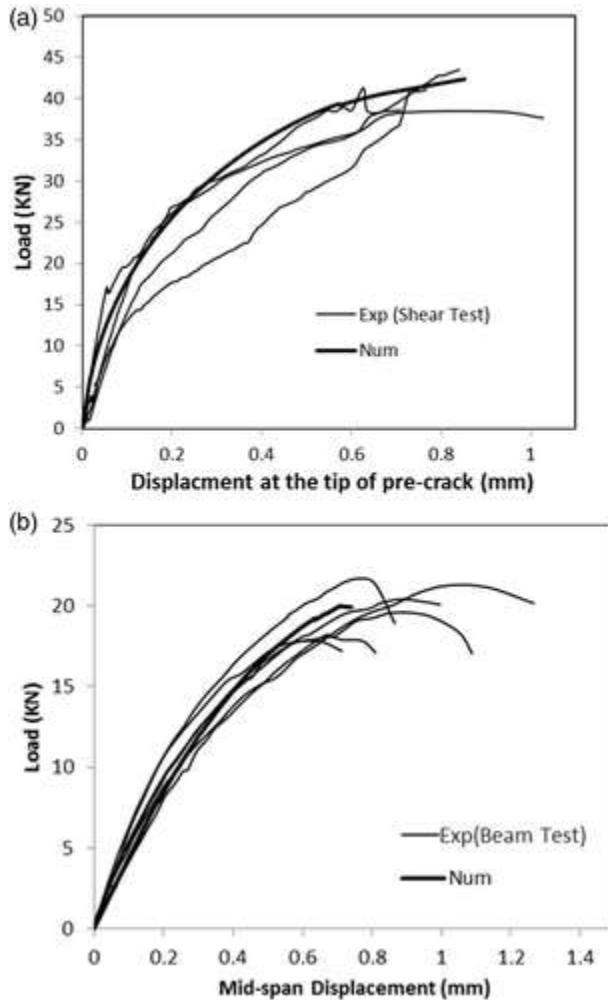
**Figure 12.** Load vs. displacement curves obtained by experimental tests and numerical analysis: (a) single shear pull-out specimens and (b) beam specimens.

Figure 12 compares the load vs displacement curves of the numerical and experimental results. Finite element method is able to predict the trend of behavior and also the maximum bearing load of the single shear pull-out test and the beam test with error of 2.2 and 2.5%, respectively.
