Complete Mouth Rehabilitation and Gastroesophageal Reflux Disease: Conventional and Contemporary Treatment Approaches

Abstract: This report describes the diagnosis and prosthodontic management of 2 patients with a history of chronic gastroesophageal reflux disease and worn dentition. Different treatment approaches were used for oral rehabilitation. Use of conventional and contemporary restorative materials resulted in functional and esthetic prosthodontic rehabilitation with a favorable prognosis.

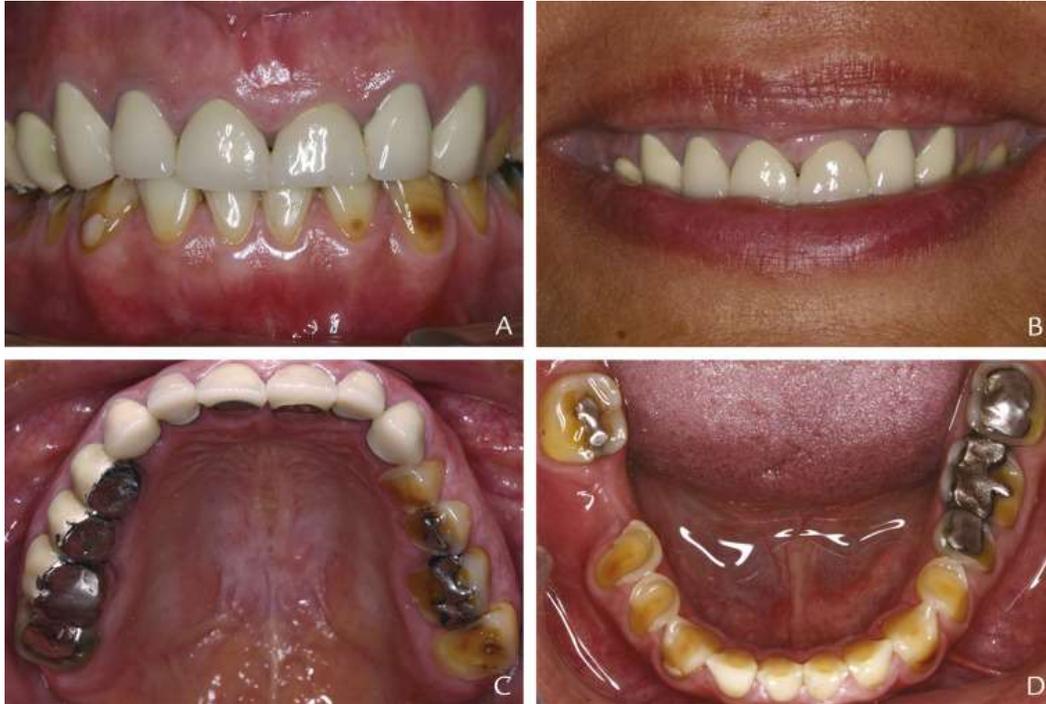
Figure 1. Patient 1 pretreatment. A, Maximum intercuspation position frontal view. B, Exaggerated smile. Note nonideal gingival display. C, Maxillary occlusal view. Note condition of existing restorations. D, Mandibular occlusal view. Note ridge defect at post extraction site of mandibular right first molar and formation of amalgam islands on left posterior teeth.

The problems identified were moderate to severe dental wear, defective restorations, inadequate tooth structure on several maxillary and mandibular teeth, inadequate anterior guidance, nonideal gingival

display in an exaggerated smile, loss of attached mucosa, and presence of a mandibular right bone defect (Fig. 1). The definitive diagnosis included worn dentition caused primarily by erosion^{9, 10, 11 and 12} and occlusal instability. Her caries risk was low.¹³ The patient was characterized as category 2 relative to the occlusal vertical dimension associated with a treatment plan¹⁴ and as prosthodontic diagnostic index (PDI) class IV for partial edentulism.¹⁵ The treatment objectives were to control GERD, to maintain periodontal and dental health, and to provide functional and esthetic restorations. Significant treatment modifiers were the GERD and finances. The patient declined bone/soft tissue augmentation and implant placement.

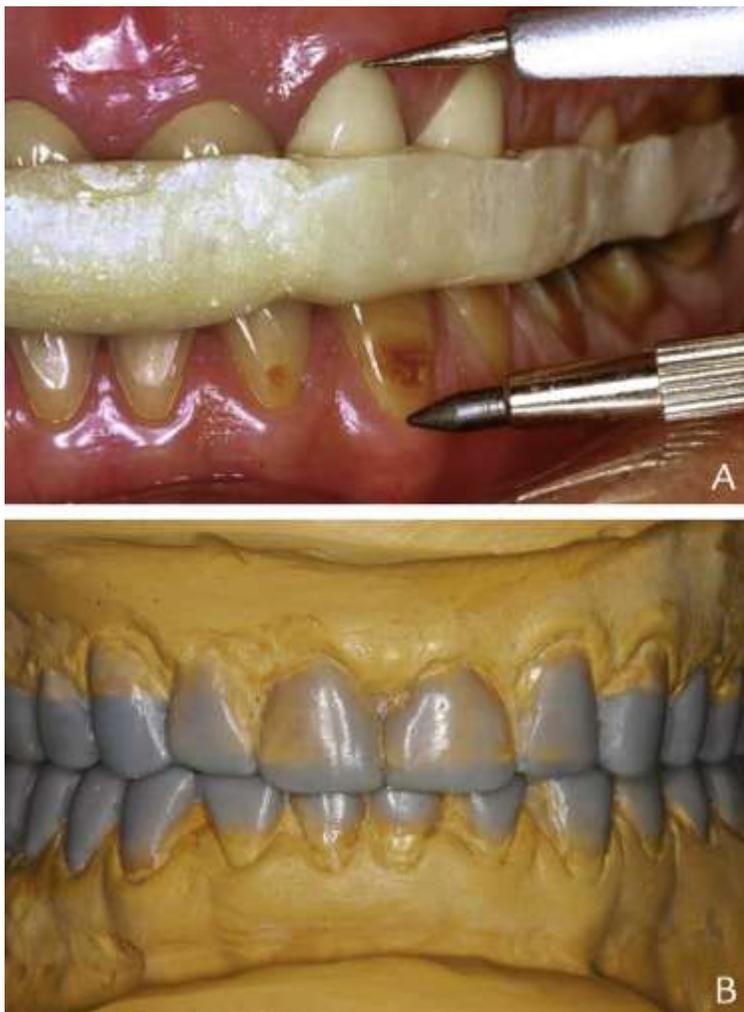
Figure 3. A, Occlusal vertical dimension evaluated with gingival height of left canines as reference. Monitored splint therapy was executed at proposed occlusal vertical dimension to locate musculoskeletally stable treatment position and evaluate patient's adaptation to new vertical dimension. B, Diagnostic waxing at proposed occlusal vertical dimension.

Diagnostic casts were obtained and mounted (Denar Mark II; Whip Mix Corp) using a facebow (Denar Slidematic; Whip Mix Corp) and centric relation records. The occlusal vertical dimension was evaluated, and a 3-mm increase was determined to allow adequate restorative space. A diagnostic waxing was used to evaluate esthetics and function and to fabricate interim prostheses (Fig. 3).

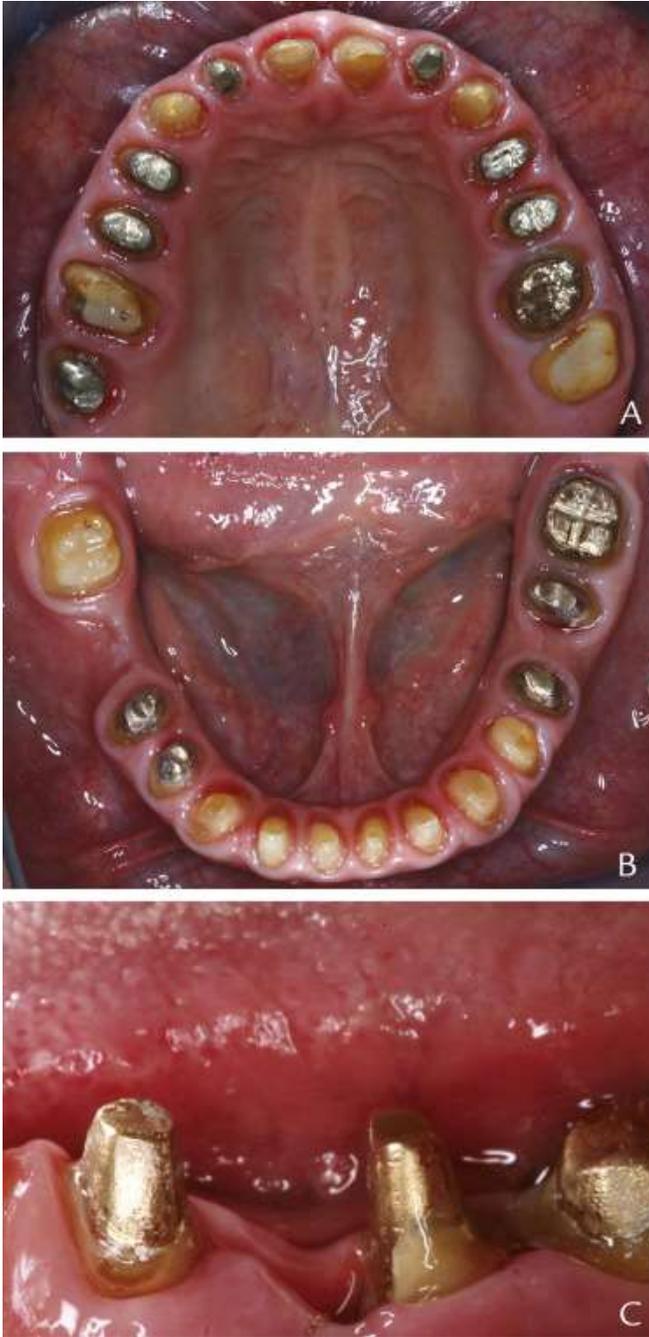
Figure 4. Tooth preparations. A, Maxillary. B, Mandibular. C, Cemented cast post/core on root-resected mandibular left first molar.

The inadequate tooth structure was managed by crown lengthening and/or cast post and cores after RCT. The maxillary central incisors were lengthened to improve gingival architecture. Strip perforation at the mesiobuccal canal of the mandibular left first molar occurred during RCT. After evaluating the tooth, resection of the mesial root was proposed,¹⁶ as the patient refused extraction and implant placement (Fig. 4). The occlusal scheme established with the interim prostheses was mutually protected articulation. The patient was monitored for 4 months to evaluate esthetics, function, oral hygiene, and soft tissue healing. Definitive impressions were made with custom trays and polyvinyl siloxane material (Aquasil Ultra; Dentsply Intl). Casts of interim prostheses were made to facilitate cross mounting of definitive casts and to fabricate a custom incisal guide table.¹⁷ The interim prostheses were used to communicate the established esthetics (incisal edge position, contours, occlusal plane) and function (occlusal scheme, envelope of function, palatal contours of maxillary anterior teeth). The patient received MC fixed dental prostheses (FDPs) on all maxillary and mandibular teeth. All prostheses were cemented with resin-modified glass ionomer cement (Fuji Plus; GC Corp).

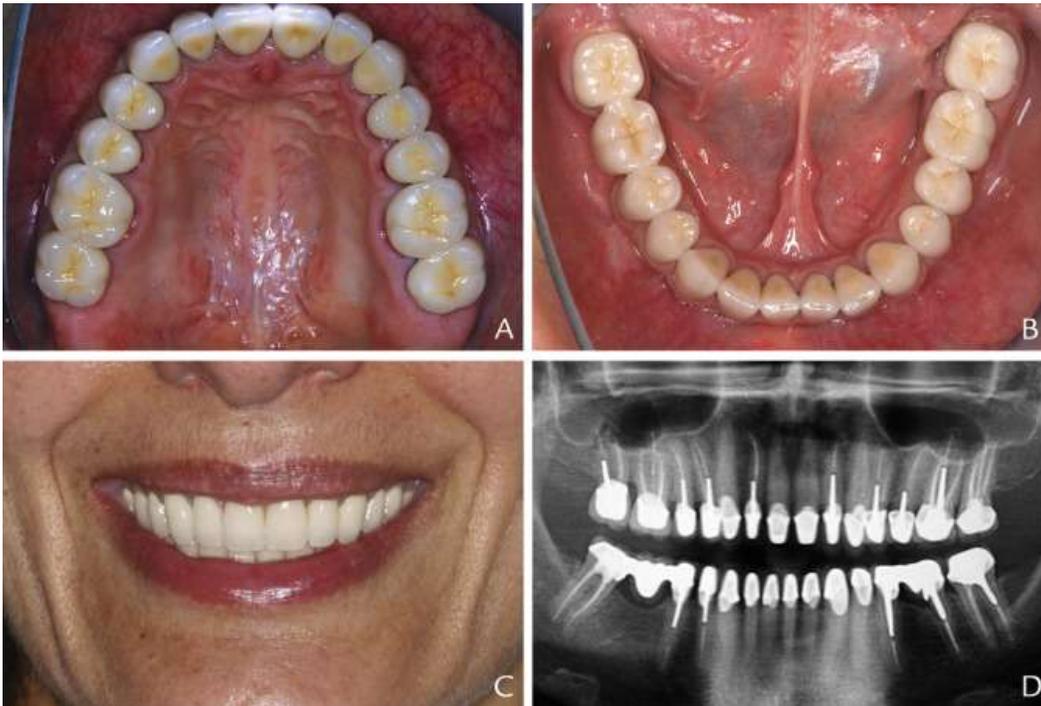
Figure 5. Patient 1. Inserted definitive prostheses. A, B, Occlusal views. C, Exaggerated smile. D, Panoramic radiograph 3 years after insertion.

The patient received follow-up examination 1 week after insertion and was excited with her rehabilitation. A maxillary occlusal device was fabricated to protect the prostheses. The patient entered a 6-month recall maintenance program with favorable long-term

prognosis. After 3 years, she was still satisfied with her prostheses (Fig. 5).

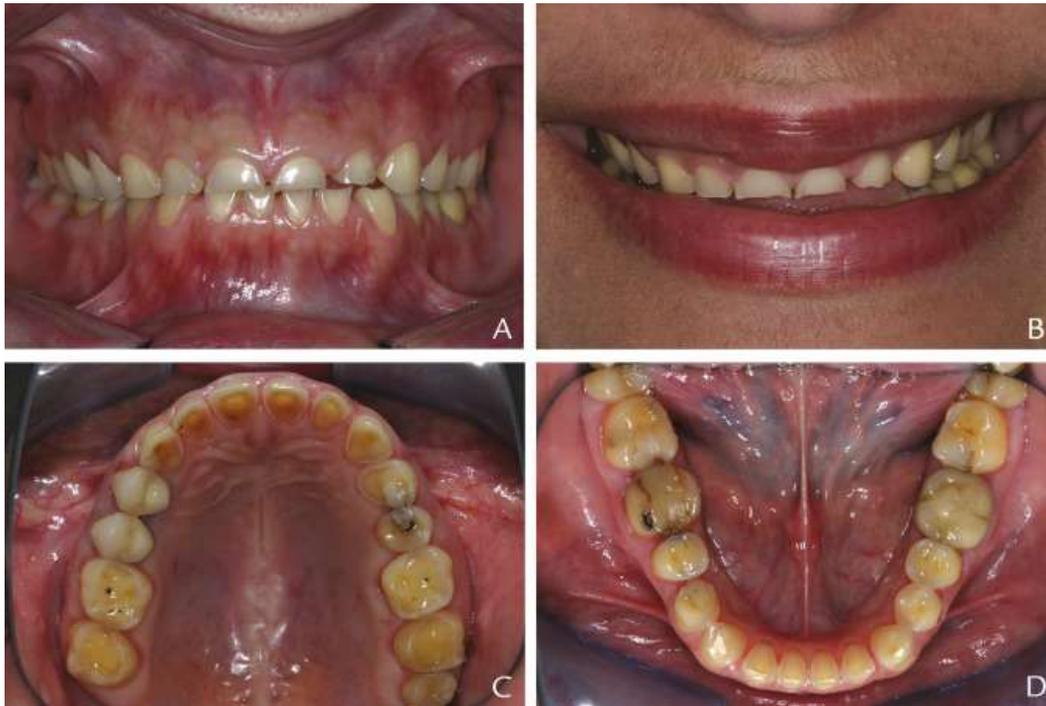
Figure 6. Patient 2 pretreatment. A, Maximum intercuspation position frontal view. B, Exaggerated smile. C, D, Occlusal views.

The problems identified were moderate dental wear, recurrent caries on several teeth, periapical pathosis on the mandibular first molars, inadequate tooth structure on the maxillary right second premolar, nonrestorable maxillary right first premolar and mandibular

left first molar, occlusal interferences, no anterior guidance in maximum intercuspation position, and uneven gingival display in an exaggerated smile (Fig. 6). The definitive diagnosis included worn dentition due to erosion and attrition,^{9, 10, 11 and 12} caries, and occlusal instability. There was no periodontal pathosis, and her caries risk was high.¹³ The patient was characterized as category 2 relative to occlusal vertical dimension associated with a treatment plan¹⁴ and as PDI class IV for completely dentate patients.¹⁹ Treatment objectives were to control GERD, to manage caries by risk assessment, to maintain periodontal health, and to perform functional and esthetic restorations. Important treatment modifiers were GERD, bruxism, and the patient's esthetic demands. Possible options to restore teeth with poor prognosis were discussed, and the patient rejected 3-unit FDPs as definitive prostheses.

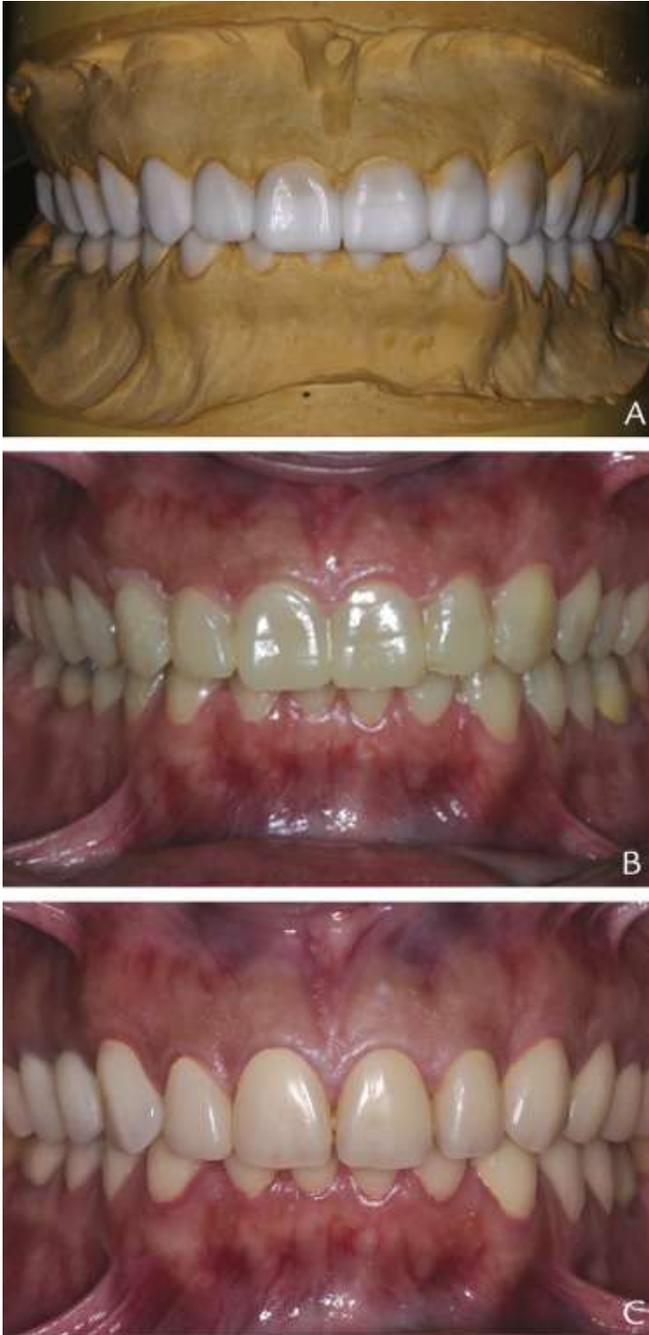
Figure 8. A, Diagnostic waxing at proposed occlusal vertical dimension. B, Intraoral evaluation of trial restorations from diagnostic waxing. C, Interim prostheses.

(Integrity; Dentsply Intl) was used as a trial restoration to evaluate the diagnostic waxing intraorally (Fig. 8).

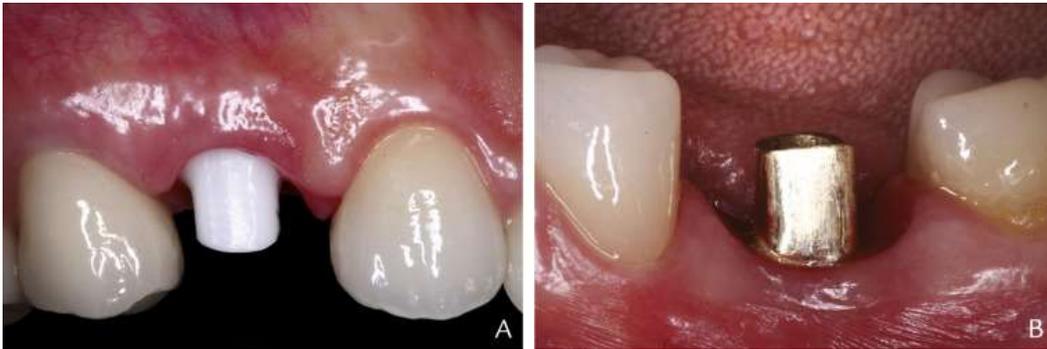
Figure 9. Implant custom abutments. A, Computer-aided designed and computer-aided manufactured (CAD-CAM) custom zirconia abutment on implant at maxillary right first premolar site. B, Custom cast gold abutment on implant at mandibular left first molar site.

Nonrestorable teeth were extracted. At the maxillary right second premolar extraction site, a ridge preservation technique was performed with freeze-dried bone allograft (RegenerOss Allograft; Biomet 3i LLC) and resorbable collagen membrane (OsseoGuard; Biomet 3i LLC). After 6 months of healing, an implant was placed with the aid of a surgical guide (Replace Select RP; Nobel Biocare). At the mandibular left first molar extraction site, implant placement and grafting were performed simultaneously (Replace Select RP; Nobel Biocare). Teeth with inadequate tooth structure were restored with composite resin core foundation material (FluoroCore 2; Dentsply Intl) after RCT. The crowns of the maxillary anterior teeth were lengthened to improve the uneven gingival display. After 4 months of healing, the implants were loaded with interim prostheses, which were fabricated based on the diagnostic waxing and which established a mutually protected occlusion scheme (Fig. 8). Esthetics, function, oral hygiene, and soft tissue maturation were monitored for 6 months. Definitive impressions and a definitive cast mounting were made as described in patient 1. A custom-made zirconia abutment (NobelProcera Abutment Zirconia; Nobel Biocare) was fabricated for the maxillary implant, and a custom-made gold alloy abutment for the mandibular implant (Fig. 9). All teeth received lithium disilicate (IPS e.max Press; Ivoclar Vivadent AG) crowns, which were adhesively cemented (Calibra; Dentsply Intl). Layered zirconia crowns were fabricated on custom abutments and cemented with resin-modified glass ionomer cement (Fuji Plus, GC Corp) (Fig. 10).

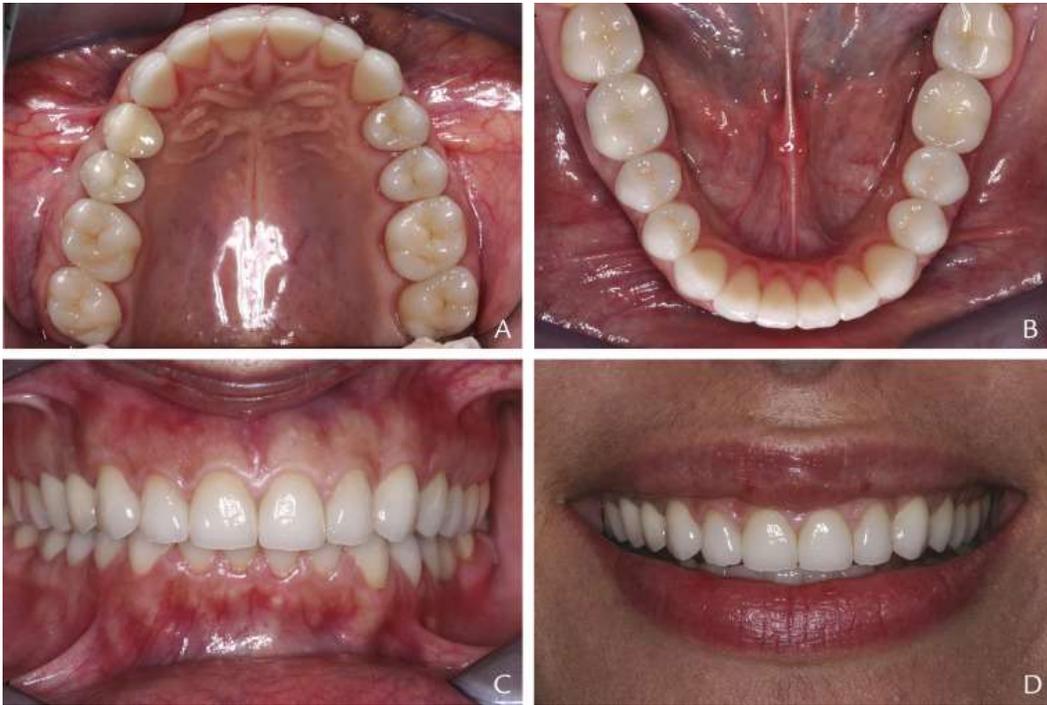
Figure 10. Inserted definitive prostheses. A, B, Occlusal views. C, Maximum intercuspation position frontal view. D, Exaggerated smile.

At the 1-week follow-up evaluation, the patient was satisfied with her new prostheses. A maxillary occlusal device was delivered at that time. The patient entered a 4-month recall maintenance program and has been followed for 2 years. The maintenance of oral and dental health were emphasized to improve the long-term prognosis.
