Enhancing the Capability of Rapid Bridge Replacement After Extreme Events

Enhancing The Capability of Rapid Bridge Replacement After Extreme Events

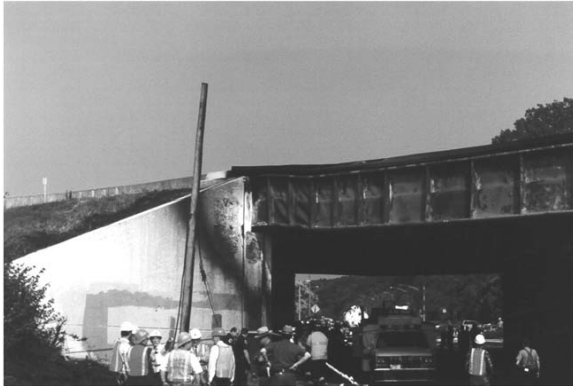
Figure 1: Overview of the damaged I-87 Bridge

A gasoline tanker-truck traveled northbound on the Central Park Avenue in New York in the early morning on Thursday October 9, 1997. The driver was making a U-turn on the Central Park Avenue as it passed underneath the New York State Thruway I-87 Bridge and was hit from behind by a sedan traveling southbound on Central Park Avenue. After the collision, the gasoline truck exploded underneath the I-87 Bridge. The explosion caused a huge fire, which killed the sedan driver and damaged the overpass bridge on the Thruway. The bridge was 24.2 meters (79.3 feet) long and a total clear span from abutment to abutment was 23.2 meters (76.0 feet) without any intermediate piers.

Structural engineers assessed the damages and concluded that the bridge was unsafe for the traveling public ([5] NYSTA, 1997a). This left the owner of the bridge, New York State Thruway Authority (NYSTA), no choice but to close the bridge immediately. The Thruway is one of the busiest commuting routes to New York City, which is used by 2,500 to 3,000 vehicles per hour in each direction in peak hours and 65,000 vehicles per day ([11] Vero and Fay, 2000). Figure 1 [Figure omitted. See Article Image.] shows the damaged I-87 Bridge.

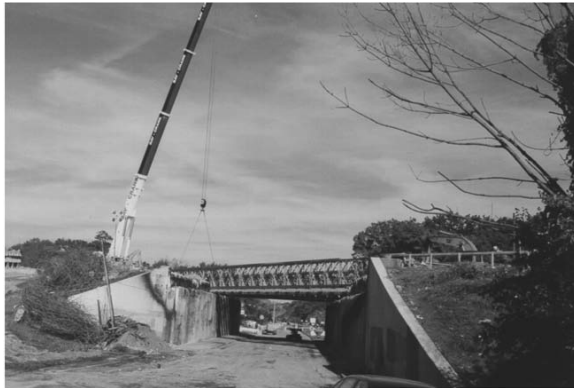
Figure 2: Two prefabricated steel truss bridges for temporary traffic detour

For this case, demolition of the damaged bridge started immediately after the incident investigation to provide space for erection of two two-lane temporary bridges, one for southbound traffic and another for northbound traffic. NYSTA determined that the use of temporary bridges would be the fastest and best way to accommodate traffic while the permanent bridge was under construction. These temporary bridges, shown in Figure 2 [Figure omitted. See Article Image.], were prefabricated steel truss structures similar to British Bailey Bridges that were developed during World War II for use in remote combat areas ([2] Burkett *et al.*, 2004). The southbound temporary bridge was about 44.8 meters (147 feet) long and the northbound bridge was about 47.2 meters (155 feet) long, spanning over the existing abutments, so that repair work on the permanent abutments could be done without interfering with the traffic above. The temporary bridges were shifted about three to five feet to the east and the supports of the bridges were built over the sidewalk of the Central Parkway Avenue. A

ten-man crew assembled the temporary bridges and installed them using stationary launch rollers and a crane. The temporary bridges were ready for use by the traveling public in only 11 days ([6] NYSTA, 1997b).

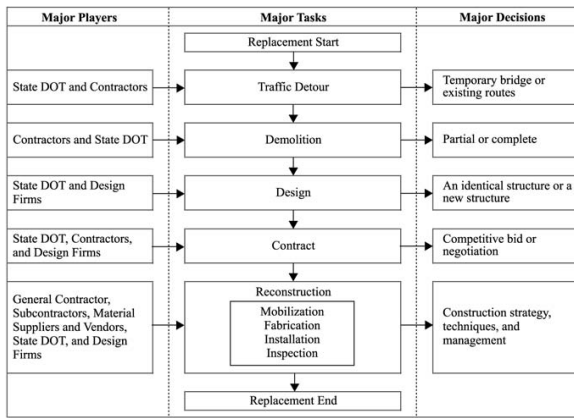
Figure 4: A general model for bridge replacement

A general model used to represent the rapid bridge replacement processes was developed through this case study, shown in Figure 4 [Figure omitted. See Article Image.]. The model includes three key elements:

1. major players;
2. major tasks; and
3. major decisions.

Major players are parties such as bridge owners, design firms, contractors, material suppliers, and vendors, who have the responsibility to conduct the bridge replacement tasks and make major decisions during the bridge replacement process. Major tasks of bridge replacement include traffic detour, demolition, design, contract, and reconstruction. At each stage, major decisions need to be made, which have significant impacts on the outcomes of bridge replacement. For example, during the design stage, the most important decision is to decide whether the bridge shall be rebuilt using an identical structure or a new structure. If the decision is to use the identical structure, then the design work is simple if the original drawings and specifications are archived. In some cases, using the identical structure may not be the best way to replace a bridge quickly. This was the case for the I-87 Bridge in New York.

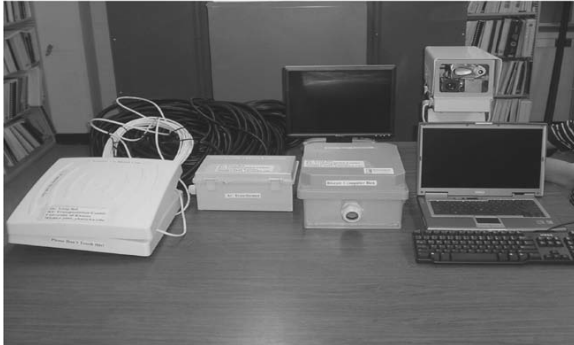
Figure 5: Major components of the wireless real-time productivity measurement system

To enhance the capability of rapid bridge replacement after extreme events, there is an urgent need to develop new technologies to address the challenges mentioned above. Currently, the research team is developing a wireless real-time productivity measurement system which includes a video camera, a data processor, an AC transformer, two antennas, and a laptop computer, see Figures 5 and 6 [Figure omitted. See Article Image.]. This system is designed to measure the construction crew productivity at the bridge site without interfering with construction operations. The technology underneath the system is based on time study theory that has proved for many years to be a very effective means for analyzing work-face activities. However, the traditional time study is conducted by employing additional people to manually collect data at the construction sites. As a result, the traditional method increases the cost, delays the analyses, and interferes with crew activities that may produce inaccurate data. The wireless real-time system overcomes these shortfalls. Using the real-time productivity data, engineers and project managers may be able to accurately determine the bridge replacement progress and easily share the information with all parties involved in the bridge replacement project. Thus, the wireless real-time productivity measurement technology has a great promise to address communication and coordination issues, to control cost overruns, to improve construction schedule forecasts, and to increase emergency response capability after extreme events. The performance of the system will be determined in the field experiments and results will be reported in the near future.

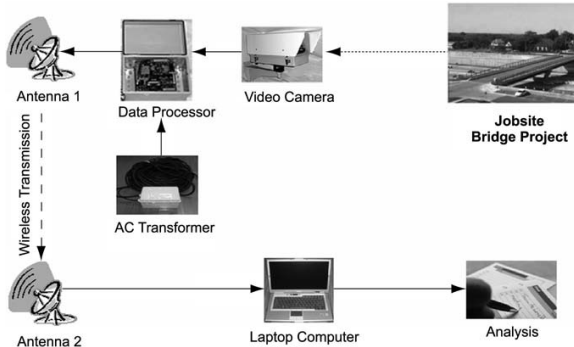
Figure 6: Framework for the wireless real-time productivity measurement system
