Reliability Testing of AlGaN/GaN HEMTs Under Multiple Stressors

Accepted version. 2011 *International Reliability Physics Symposium* (April 10-14, 2011). DOI. © 2011 Institute of Electrical and Electronic Engineers (IEEE). Used with permission.

We performed an experiment on AlGaN/GaN HEMTs with high voltage and high power as stressors. We found that devices tested under high power generally degraded more than those tested under high voltage. In particular, the high-voltage-tested devices did not degrade significantly as suggested by some papers in the literature. The same papers in the literature also suggest that high voltages cause cracks and pits. However, the high-voltage-tested devices in this study do not exhibit cracks or pits in TEM images, while the high-power-tested devices exhibit pits.

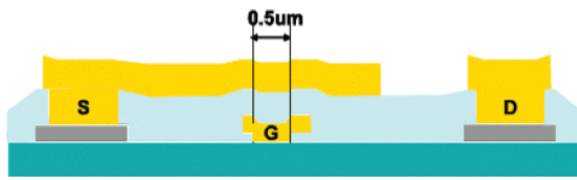
Figure 1. Schematic diagram of tested devices. [9]

The devices used in this study were pulled from two wafers from the same lot. The AlGaIn/GaN HEMT structure (from a commercial foundry) consists of a SiC substrate, a gate integrated field plate, and a source-connected field plate. Gate length is $0.5 \mu\text{m}$ and periphery is $2 \times 50 \mu\text{m}$. See Fig. 1 for a schematic diagram of the tested devices. Additional structure details can be found in [7] and [8].

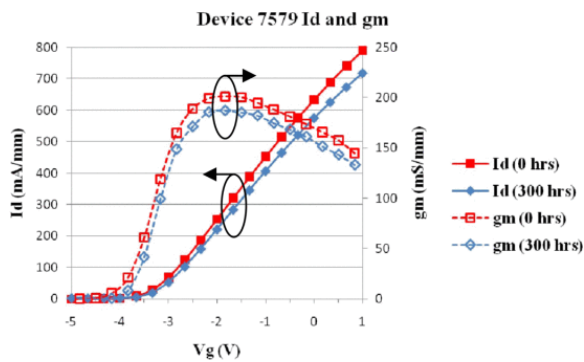
Figure 2. Transfer and transconductance curves at 0 and 300 hours of typical high-voltage-tested device. Device 7579 was tested at Condition 5.

Fig. 2 shows the transfer and transconductance curves of a typical (meaning, following the general trends in I_{Dmax} , I_{DSS} , and V_T) high-voltage-tested device. Fig. 3 shows the transfer and transconductance curves of one of the two exceptional high-voltage-tested devices. Figs. 2 and 3 illustrate the variability in the performance of the tested HEMTs. Although discovering the cause of the negative threshold voltage shift in Fig. 3 was not an objective of this study, a possible explanation is a trapping phenomenon near the gate [10], [11]. The transfer and transconductance curves of Fig. 4 are representative of the power-tested devices. Figs. 3 and 4 contain the transfer and transconductance curves from testing subsequent to the initial 300 hours; these curves show little change after 300 hours.

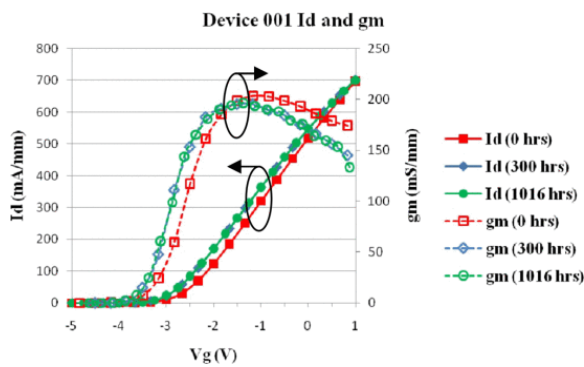
Figure 3. Transfer and transconductance curves at 0, 300, and 1016 hours of exceptional high-voltage-tested device. Device 001 was tested at Condition 5.

Condition 5 exhibited increases in I_{DSS} and negative threshold voltage V_T shifts. The same device at Condition 5 also exhibited an increase in I_{Dmax} (see Fig. 3). All devices experienced decreases in peak transconductance g_{mp} and increases in R_{on} . The other general trends were positive threshold voltage shifts and decreases in I_{Dmax} and I_{DSS} .

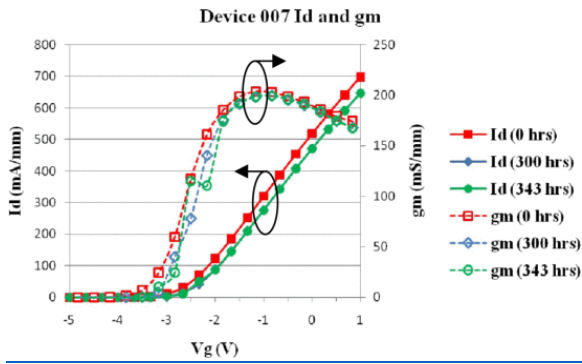
Figure 4. Representative transfer and transconductance curves at 0, 300, and 343 hours of high-power-tested device. Device 007 was tested at Condition 1.

After stress testing, we investigated the four select devices by thermal and photoemission imaging in a Quantum Focus Instruments InfraScope™. In three of the four devices, hot spots corresponded with bright spots. We delivered these four devices to NanoTEM for transmission electron microscope (TEM) imaging at the hot and bright spots. Although Device 001 is exceptional (with a negative V_T shift and increases in I_{Dmax} and I_{DSS}), its transfer and transconductance curves and its infrared (IR), photoemission (PE), and TEM images are shown since it had notable IR and PE images, whereas the other imaged high-voltage-tested device did not. Fig. 5 contains IR (radiance) and PE images for the high-voltage-tested Device 001 whose transfer and transconductance curves are in Fig. 3. (An insufficient number of samples were imaged by IR and PE to determine whether the features of Fig. 5 correlate to the negative threshold voltage shift of Fig. 3.) The IR (radiance) and PE images in Fig. 6 are those of the power-tested Device 007 whose transfer and transconductance curves are in Fig. 4.

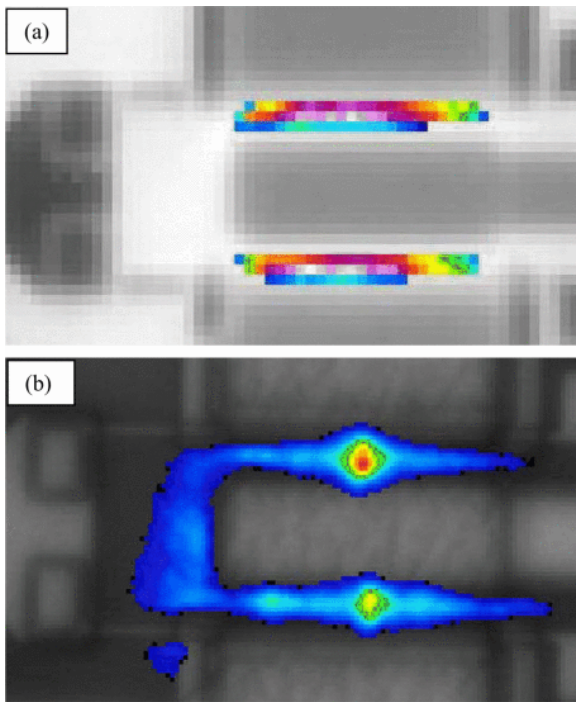
Figure 5. Device 001 (high-voltage-tested) at a baseplate of 85°C. The upper middle spot was targeted for TEM imaging. (a) IR (radiance) image at 15X magnification. $V_{DS} = 40V, I_D = 10mA, V_{GS} = -2.42V, I_G = -5\mu A$ (b) PE image at 20X magnification. $V_{DS} = 100V, I_D = 11\mu A, V_{GS} = -10$.

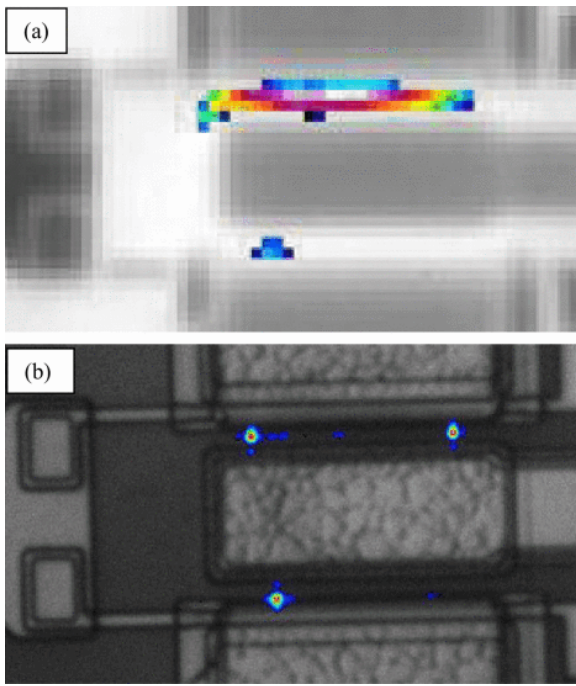
Figure 6. Device 007 (high-power-tested) at a baseplate of 85°C. The lower left spot was targeted for TEM imaging. (a) IR (radiance) image at 15X magnification. $V_{DS} = 28V, I_D = 10mA, V_{GS} = -1.69V, I_G = -3.3\mu A$, (b) PE image at 50X magnification. $V_{DS} = 10V, I_D = 3.2mA, V_{GS} = -1V, I_G$ in nA range.

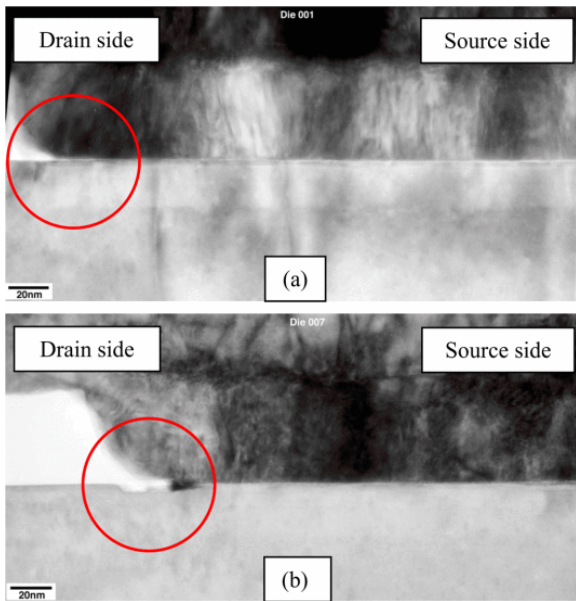
Figure 7. TEM images of (a) Device 001 (high-voltage-tested) and (b) Device 007 (high-power-tested). Notice absence of a pit or crack in Device 001 and the presence of a pit in Device 007.

The TEM images of Devices 001 and 007 are in Fig. 7. As in the TEM image of Device 001 (stressed at Condition 5), the other high-voltage-tested part that was imaged by TEM, Device 7632 (stressed at Condition 4), does not exhibit a crack or pit at the drain edge of the gate. This is contrary to the findings reported in [4]. However, in the TEM images of the two high-power-tested devices, Devices 007 and 008 (not shown), that were both stressed at Condition 1, small pits have formed at the drain edge of the gate. Thus, current appears necessary to create the pits in the AlGaIn layer.
