# Resistance to Fracture of Two All-Ceramic Crown Materials Following Endodontic Access

Accepted version. *The Journal of Prosthetic Dentistry*, Vol. 95, No. 1 (January 2006): 33-41. DOI. ©  
2006 Elsevier B.V. Used with permission.

The purpose of this [in vitro](#) study was to evaluate how an endodontic access opening prepared through an all-ceramic crown altered the structural integrity of the ceramic, and the effect of a repair of this access on the load to failure of an all-ceramic crown.

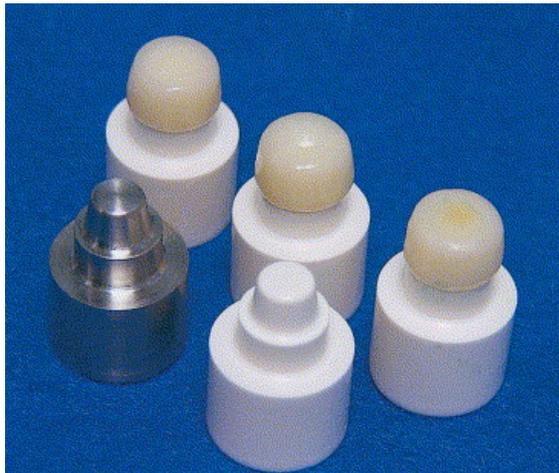
Fig. 2. Stainless steel master die and duplicated high-heat epoxy die (left to right, front diagonal row). Intact alumina crown, accessed alumina crown, and repaired alumina crown (left to right, back diagonal row).

The access openings in Groups AR and ZR were repaired with a porcelain repair system (All-Bond 2 Porcelain Repair Kit; Bisco, Inc, Schaumburg, Ill) and a direct restoration.<sup>22, 23, 24</sup> Each crown was individually repaired using the following protocol: porcelain etchant 4% hydrofluoric acid gel, 4 minutes, rinse; porcelain silane [primer](#), 2 minutes, air dry; All-Bond 2 primer A & B, 5 coats, air dry; and dentin/enamel resin, air thin, light polymerize (Elipar Highlight; 3M ESPE, Seefeld, Germany), 40 seconds.<sup>25</sup> Two increments of [composite resin](#) (XRV Herculite Unidose Hybrid Composite Resin, shade enamel A3; Kerr Corp, Orange, Calif), each with a 40-second light polymerization, completed the repair. The occlusal aspect of the repair was made level with adjacent porcelain, and the external repair flash was removed with a carver (Hollenback 3S; Henry Schein Inc, Melville, NY). The composite resin repair and porcelain occlusal surface interface was smoothed with 1200-grit silicon carbide paper (Buehler Ltd, Lake Bluff, Ill). A repaired crown with a master die, duplicate die, intact crown, and accessed crown are shown in [Figure 2](#).

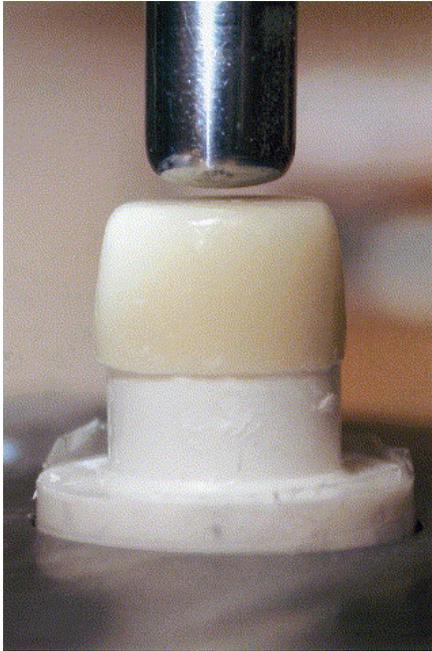
Fig. 3. Loading piston was 6.35 mm in diameter along its long axis, with its end machined to curvature equivalent to 50 mm in diameter, which contacted center and approximate same area of each crown.

Specimens were positioned in a custom-made mechanical fixture positioned on a load cell. Each specimen was loaded to failure along its long axis at a rate of 0.2 mm/min in a universal testing machine (Model 55R1114; Instron Corp, Canton, Mass). The loading piston was 6.35 mm in diameter along its long axis, with its end machined to a curvature equivalent to a 50-mm diameter. A loading piston of this dimension avoids high-contact stresses on loading.<sup>26, 27</sup> The end of the loading piston contacted the center of the occlusal surface of each crown ([Fig. 3](#)). This loading position has been used in other studies<sup>19, 20, 28</sup> and, to maintain consistency, was used in loading both the intact and repaired specimens. After initial contact on the repaired specimens, the piston surface contacted both the composite resin repair as well as the surrounding porcelain. Failure load was recorded in kilogram force (kgf) and designated as the maximum compressive load prior to a greater than 5% drop in load and/or visualization of significant crack formation. Force data for all specimens were converted to newtons (N)
