## Shattered Rim and Shelling of High-Speed Railway Wheels in The Very-High-Cycle Fatigue Regime Under Rolling Contact Loading

*Engineering Failure Analysis*, Vol. 97 (March 2019): 556-567. [DOI](#). This article is © Elsevier and permission has been granted for this version to appear in [e-Publications@Marquette](#). Elsevier does not grant permission for this article to be further copied/distributed or hosted elsewhere without the express permission from Elsevier.

Due to the improvement of the wear property, rolling contact fatigue including shattered rim and shelling are the main failure causes of the high-speed railway wheels. In this paper, shattered rim and shelling occurred on the service wheels of the China Railway High-speed (CRH) trains were systematically investigated. The recorded data of the last ten years CRH operation indicated that all shattered rims and shelling were detected with serving  $>10^6$  km (corresponding to the fatigue life  $10^7$ – $10^9$  cycles) which is very-high-cycle fatigue (VHCF). The crack initiation region of shattered rim located at the depth of 10–25 mm from the tread, while that of shelling located at the depth  $<10$  mm from the tread.

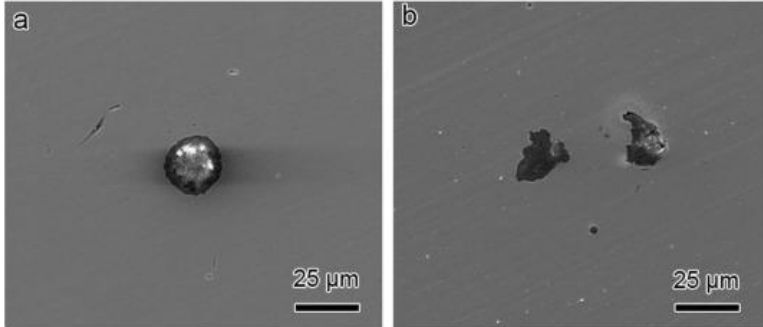
The microstructure under the tread is abundant pearlite with trace ferrite (Fig. 3a). The microstructure in the interior was found to consist of pearlite and ferrite (Fig. 3b), and the distribution of the ferrite is heterogeneous. Fig. 4 presents the typical inclusions in the wheel steels. The size of the inclusion is about 20  $\mu\text{m}$ . Nonmetallic inclusion is prevalent in the steels. The aluminium acted as deoxidizer during the smelting processing of steels which results in the introduction of aluminium oxide inclusions to steels. In addition, the mechanical properties of the material were measured by tensile testing on an MTS 810 system with cylindrical specimens of 6 mm in diameter and at a strain rate of  $10^{-4} \text{ s}^{-1}$ . Five specimens were tested to obtain the yield strength of 673 MPa, the tensile strength of 950 MPa and the uniform elongation of 11.5% for the material.

Fig. 4. Inclusions in the steels, (a) Type I, and (b) Type II.
