*Engineering Failure Analysis*, Vol. 97 (March 2019): 556-567. [DOI](#). This article is © Elsevier and permission has been granted for this version to appear in [e-Publications@Marquette](#). Elsevier does not grant permission for this article to be further copied/distributed or hosted elsewhere without the express permission from Elsevier.

# Shattered Rim and Shelling of High-Speed Railway Wheels in The Very-High-Cycle Fatigue Regime Under Rolling Contact Loading

## Abstract

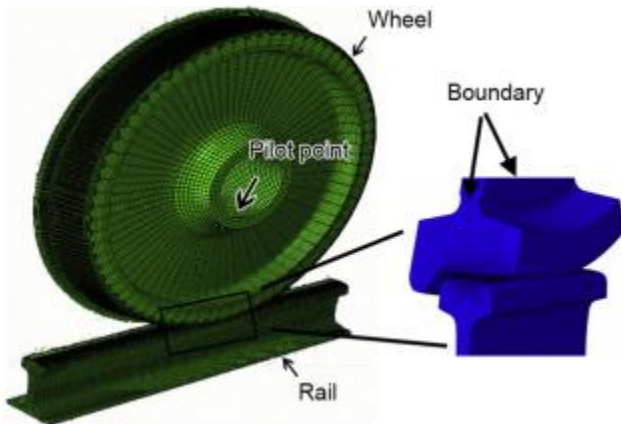
Fig. 5. 3D finite element model of wheel/rail contact.

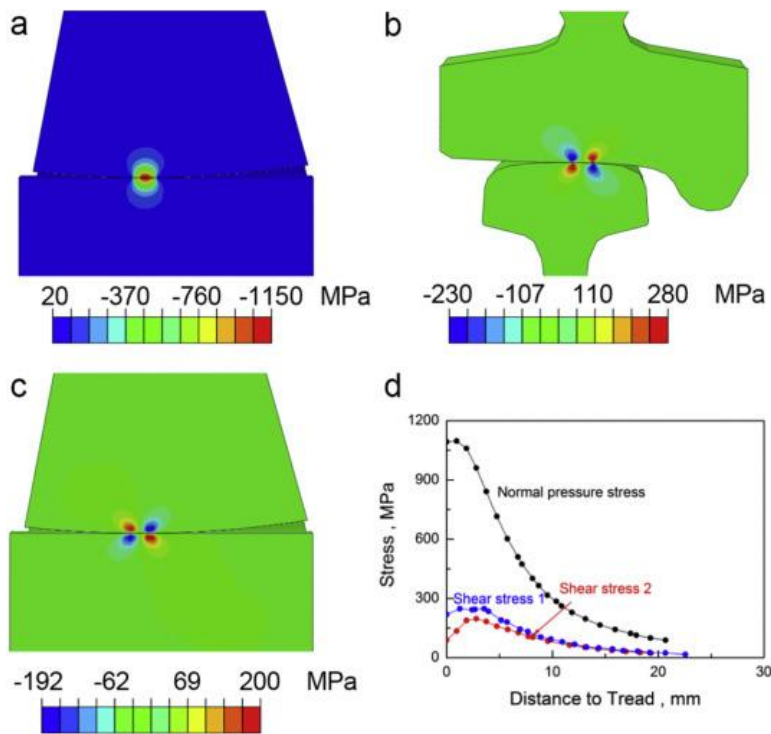
As mentioned above, the fracture surfaces for the case of interior and subsurface crack initiation are different, which is attributed to the stress distribution of rolling contact loading. Here, finite element method was applied to analyze the stress around the contact surface. The multiaxial stress consists of a pressure stress in the radial direction (Fig. 14a), a shear stress in axle direction (Fig. 14b) and a shear stress in circumference direction (Fig. 14c). The results in Fig. 14 indicated that only a small region of the contact location bears high stress, the maximum stress located at the depth of about 2 mm while the stress in the other parts of the wheel is almost zero. Fig. 14d presents the stress variation along the radial direction of the wheel. For the case of shelling (subsurface crack initiation) with the depth 0–10 mm, the pressure stress is very high and decreases with the increase of the depth. The existence of the high pressure will cause the severe plastic deformation near the tread (Fig. 10c and 12c) and the press of the crack surfaces (Fig. 9b and 11b). The two shear stress increase first from the tread surface to the 2 mm depth of the wheel, and the maximum shear stress occurs at about 2 mm depth from the tread. These two shear stresses are the driven force of the subsurface crack initiation and propagation. For the case of shattered rim (interior crack initiation) with the depth 10–25 mm, the pressure stress is in the elastic stage, and no evident press between the crack surface was observed (Fig. 6). Meanwhile, the two shear stresses are also in the low level. It is consistent with VHCF features of a relatively low cyclic stress below conventional fatigue limit and beyond  $10^7$  fatigue cycles.

Fig. 14. Stress distribution of wheel/rail contact, (a) pressure stress contour in radial direction, (b) shear stress contour in axle direction, and (c) shear stress in circumference direction, and (d) stress variation along the radial direction of the wheel.

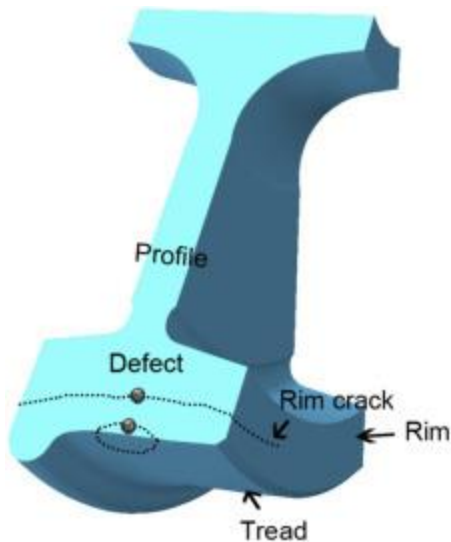
Fig. 17 presents the schematic for the formation mechanism of shattered rim and shelling induced by defects. When the defect locates at the subsurface of the tread with the depth  $<10$  mm, crack induced by the defect will prefer to propagate to the tread instead of the rim, called shelling. This will cause damage on the tread, and influence the service of the wheel. With turning repair, the wheel can continue the service. When the defect is located at interior of the wheel and is deeper than 10 mm, the crack will propagate to the rim instead of the tread. The shattered rim will lead to the failure of the wheel, even disaster to the train. Models such as “hydrogen assisted crack growth” [27,28], “decohesion of spherical carbide” [29,30], and “formation and debonding of fine granular layer” [19,20] have been proposed for describing the crack initiation mechanism for the VHCF of steels. For the mechanism of “hydrogen assisted crack growth”, it was stated that the existence of locally concentrated hydrogen trapped by a defect induced the discrete crack growth at a very slow rate during crack initiation. The mechanism of “decohesion of spherical carbide” attributes the decohesions of spherical carbides from the matrix to the crack initiation of VHCF. The debondings of the fine granular layer and the matrix are responsible for the early cracks in the model of “formation and debonding of fine granular layer”.

Fig. 17. Schematic of shattered rim and shelling induced by defects.
