Analysis of Load-Induced Strains in a Hot Mix Asphalt Perpetual Pavement

WisDOT Report FEP 01-09

Wisconsin Research Study # FEP-02-02
“EVALUATION OF AN ASPHALTIC CONCRETE PERPETUAL
PAVEMENT”
(Kenosha Safety & Weigh Station Facility)

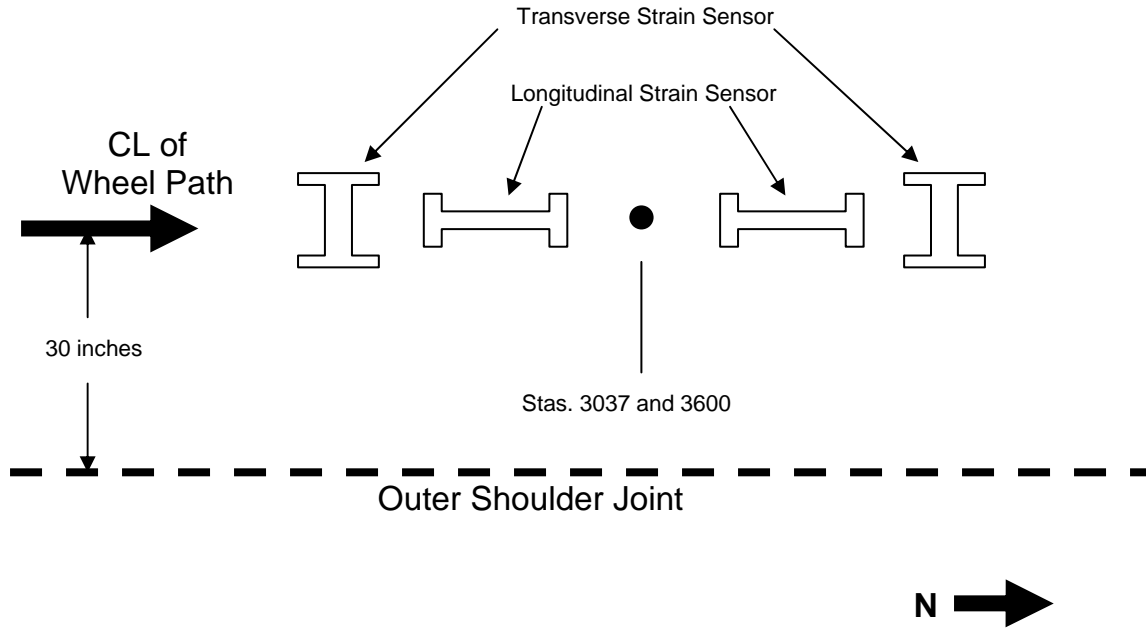
Figure 1: Schematic Illustration of Strain Sensor Configurations

Marquette University was contracted to design, build and install asphalt strain sensors to record load-induced strains within the HMA perpetual pavement system. A total of 16 H-Type strain sensors were fabricated and installed in the outer wheel path at stations 3037 and 3600. Eight sensors were installed at the bottom of the lower HMA layer and the remaining eight sensors were installed at the interface of the lower and middle HMA layers. Figure 1 provides a schematic illustration of the sensor arrangement used at each placement/depth location. As shown, there is a redundant set of longitudinal and transverse oriented strain sensors at each instrumented location.

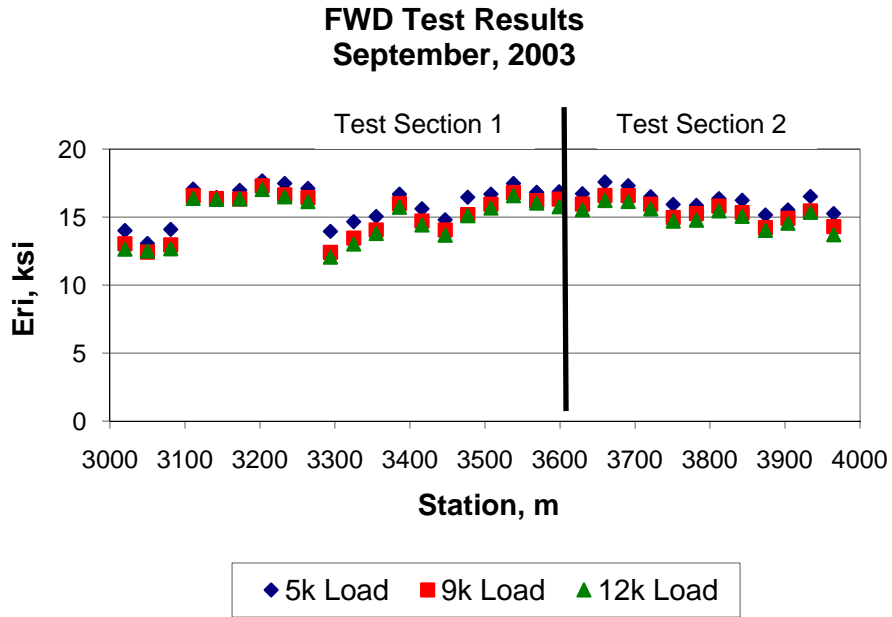
Figure 2: Backcalculated Subgrade Eri Profile, Sept. 2003

As shown in Figure 2, the backcalculated subgrade Eri values are relatively consistent within Test Section 2 and more variable in Test Section 1. Furthermore, the deflection results indicate a slight stress sensitivity in the lean clay soils, whereby there is a minor reduction in the backcalculated Eri values with increasing FWD load levels. This trend of stress-softening is typical for fine grained, cohesive soil materials. Summary statistics for the backcalculated subgrade Eri values are provided in Table 1.

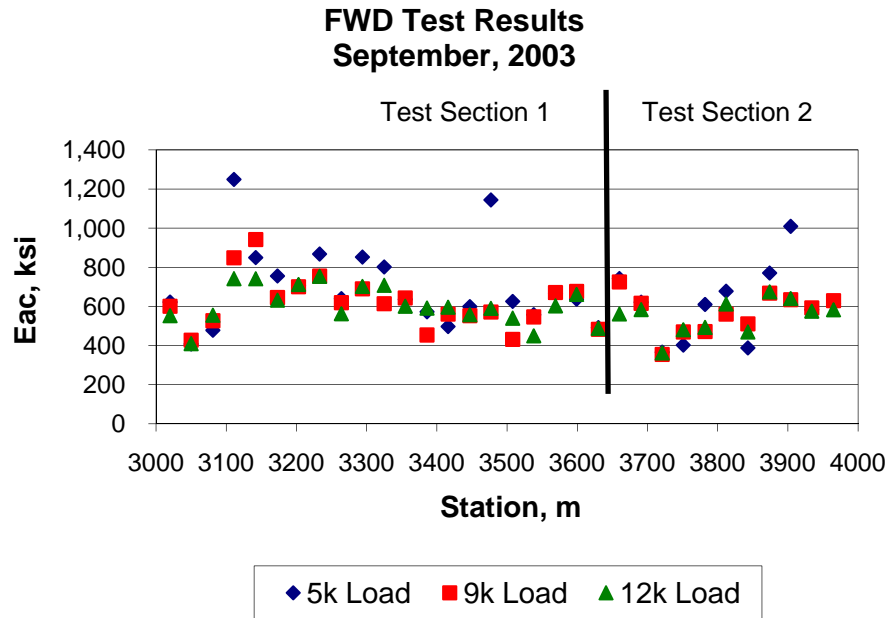
Figure 3: Backcalculated HMA Modulus Profile, Sept. 2003

The backcalculated E_{AC} values illustrated in Figure 3 and provided in Table 2 indicate relative consistency within each test section; however, there is more variability compared to the backcalculated Eri values (i.e., higher COV values). Also, the overall average E_{AC} values are increased within Test Section 1 as would be expected due to the reduced air voids in the lower HMA layer.

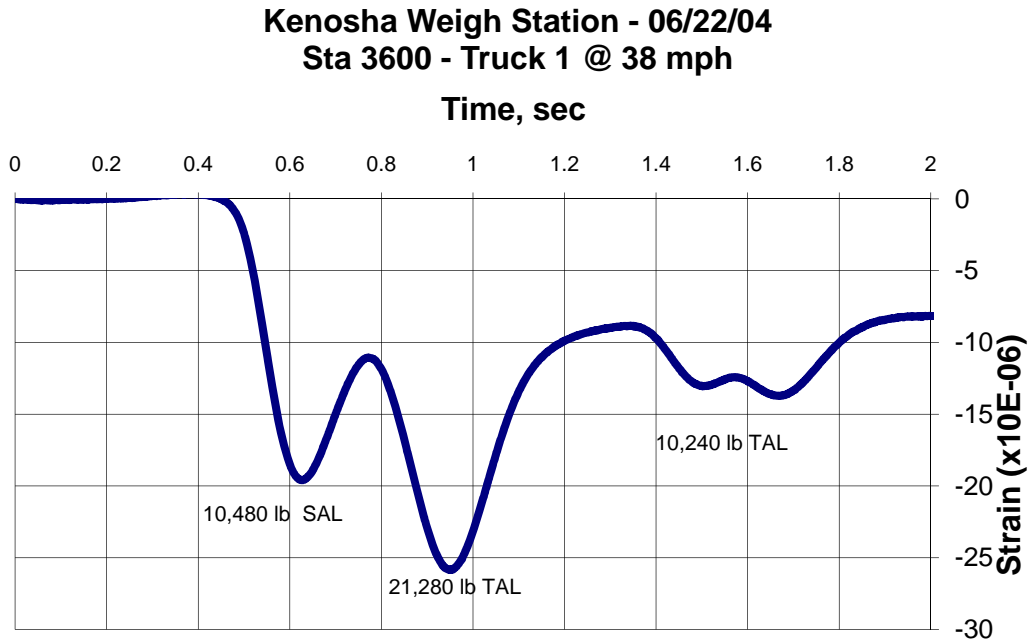
Figure 4: Strain Measurement from Truck 1 – June 2004

Strain measurements were made in conjunction with moving truck loadings to establish trends of strain data as a function of speed, load magnitude and position. On June 24, 2004 a series of strain measurements were obtained in Test Section 2 (Station 3600) under the action of FHWA Class 9 trucks (WisDOT Designation 3S-2). Strain measurements were captured at the bottom of the HMA layer for four separate trucks traveling between 37 – 42 mph. Axle loadings were obtained from the weigh station records and ranged from 10,480 – 12,740 lb on the steering axle and from 10,240 – 34,680 lb on the dual-tandem axle. Figures 4 – 7 illustrate the maximum strain readings obtained under each axle of the four truck loadings. As shown, the peak strain values (tension is negative) produced by the single axle loads (SAL) and tandem axle loads (TAL) are well correlated to the magnitude of the axle loadings and all strain reading are below 50 microstrain.

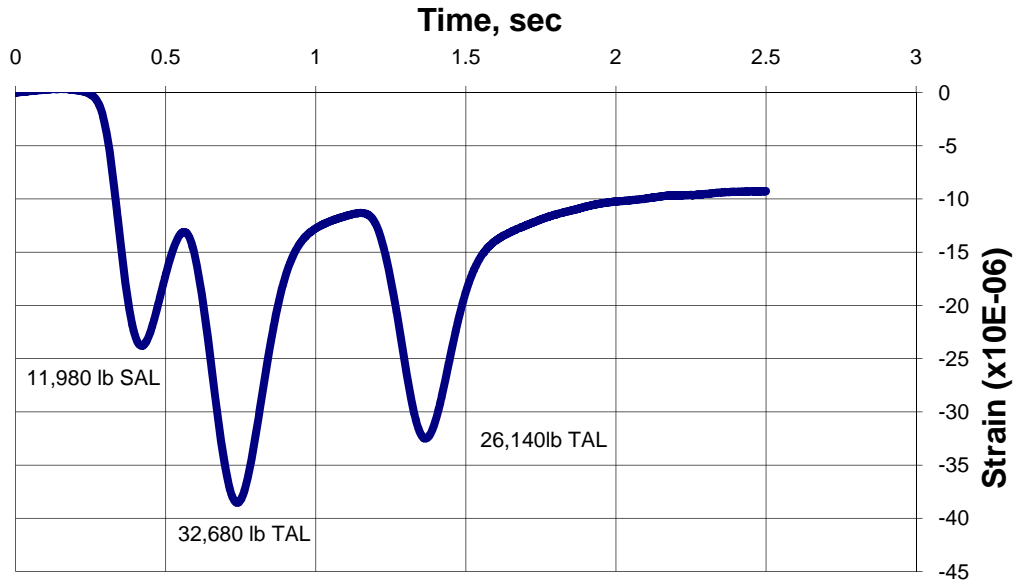
**Kenosha Weigh Station - 06/22/04
Station 3600 - Truck 2 @ 41 mph**

Figure 5: Strain Measurement from Truck 2 – June 2004

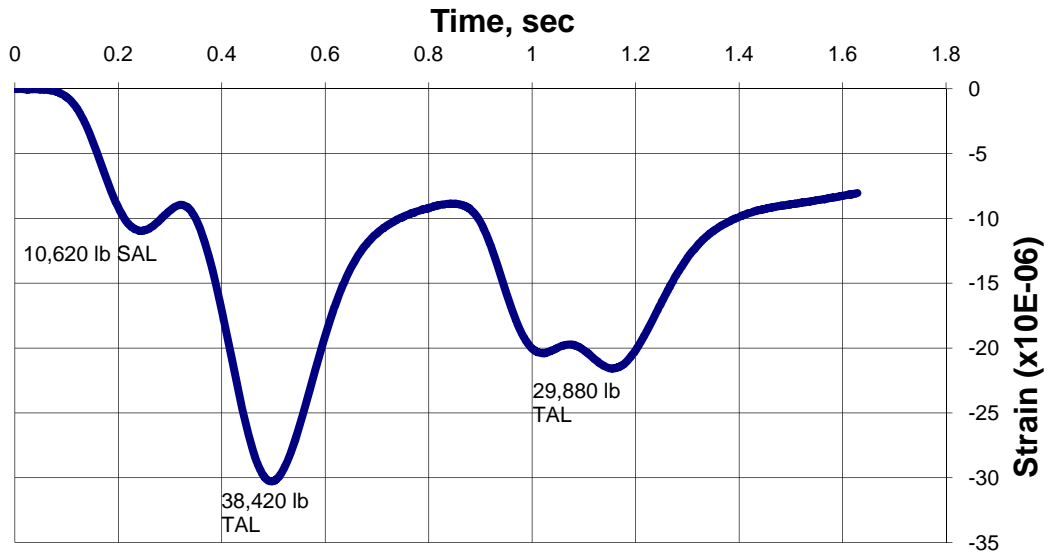
**Kenosha Weigh Station - 06/22/04
Station 3600 - Truck 3 @ 42 mph**

Figure 6: Strain Measurement from Truck 3 – June 2004

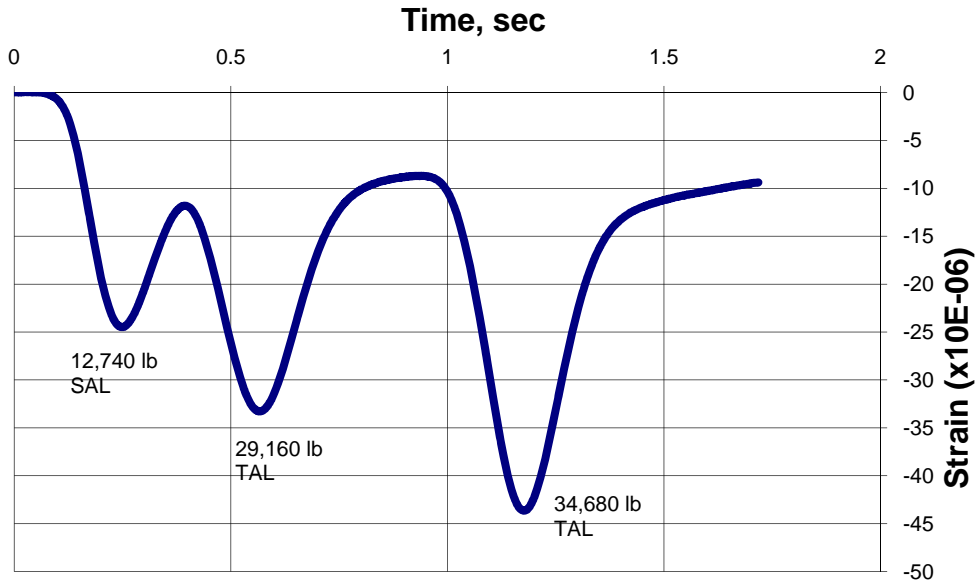
**Kenosha Weigh Station - 06/22/04
Station 3600 - Truck 4 @ 37 mph**

Figure 7: Strain Measurement from Truck 4 – June 2004

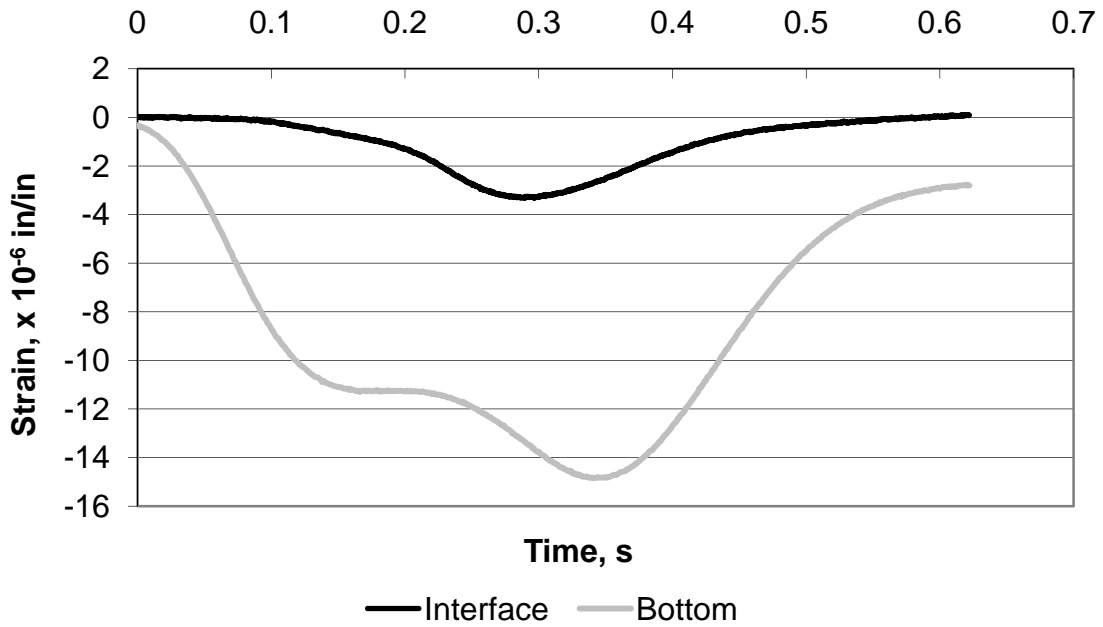
**Kenosha Weigh Station - April 2005
Dump Truck Run 1- Pushers Down @ 55 Mph**

Figure 8: Strain Measurement from Truck Run 1 – April 2005

A second series of truck measurements were made on April 18, 2005 using a loaded quad-axle dump truck with a total gross vehicle weight of approximately 72,700 lb. Strain measurements were obtained from the bottom and interface sensors at Station 3600. Pavement surface temperatures ranged from 80.2 to 90.8 °F during testing. Two truck runs were recorded with the pusher wheels up, which results in a steering axle loading of approximately 25,400 lb and a rear dual-tandem axle loading of approximately 47,300 lb. An additional truck run was recorded with the pusher axles down, resulting in a steering axle loading of approximately 19,000 lb, a rear dual-tandem axle loading of approximately 38,600 lb and a pusher axle loading of approximately 15,000 lb. Figures 8 - 10 illustrate the results of these truck tests. As shown, the bottom strain readings are significantly higher than the interface values, as expected. Furthermore, all strain readings are below 25 microstrain.

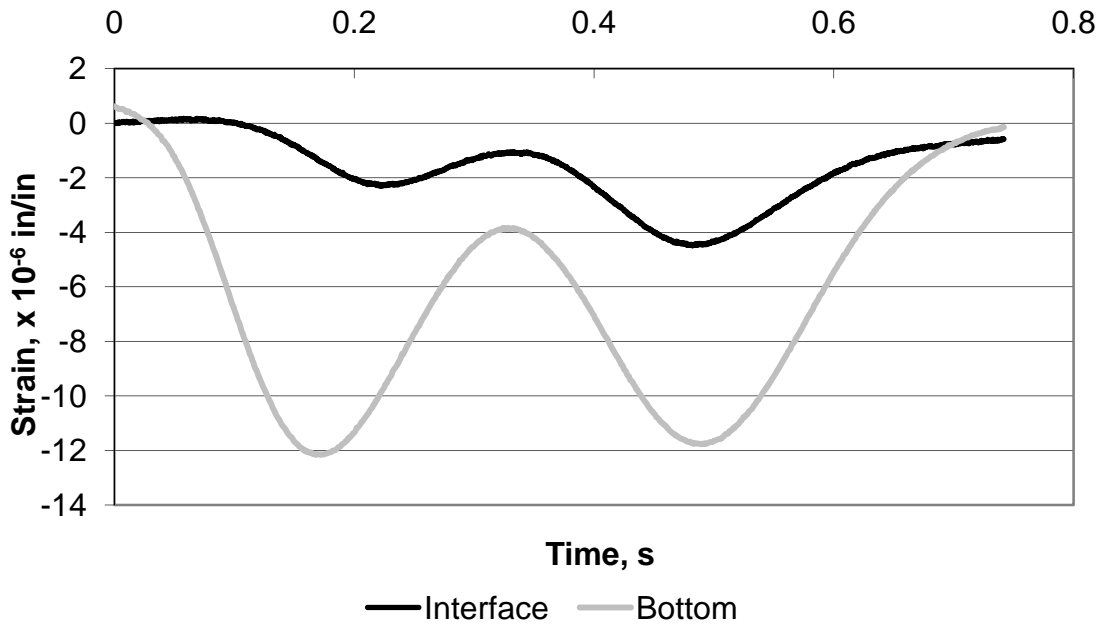
**Kenosha Weigh Station - April 2005
Dump Truck Run 2 - Pushers Up @ 40 Mph**

Figure 9: Strain Measurement from Truck Run 2 – April 2005

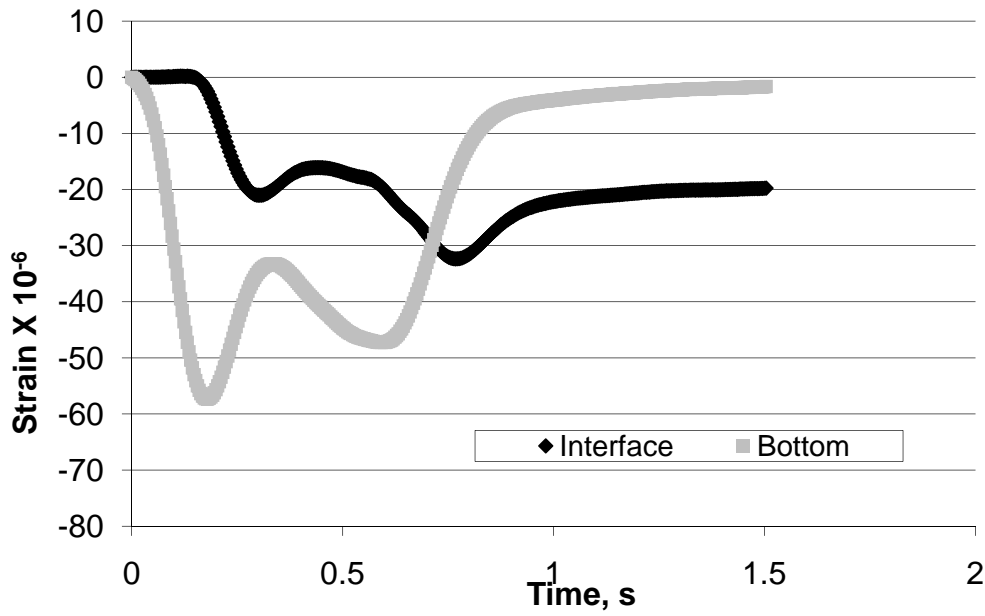
**Test Truck - Wheels Down - Run 1
7/26/2005 - 28 mph - 11" Right**

Figure 11: Strain Measurement from Truck Run 1 – July 2005

A final series of truck measurements were conducted on July 26, 2005. Strain measurements were obtained from the bottom and interface sensors at Station 3600. These measurements were again made under the action of the loaded quad-axle dump truck with a total gross vehicle weight of approximately 72,700 lb. Pavement surface temperatures ranged from 90 to 103 °F during testing. Four truck runs were recorded with the pusher wheels down (19,000 lb SAL, 38,600 lb TAL, 15,000 lb PAL). Four additional truck runs were recorded with the pusher axles up (25,400 lb SAL and 47,300 lb TAL). During each run, the position of the right front steering wheel was recorded in reference to the centerline of the right wheel path. Figures 11 - 18 illustrate the results of these truck tests. As shown, the strains recorded during this testing are substantially higher than during the previous test series in April 2005, likely due to the higher pavement temperatures and slower truck speeds. In particular, the effects of speed on strain development can be seen by comparing Figures 12 and 13, which clearly demonstrate the increase in strains resulting from reduced truck speeds (equal offset values). When the pusher axles were lowered (legal loadings) all strain readings were below 70 microstrain. With the pusher axles raised, slower truck speeds produced bottom layer strains in excess of 100 microstrain under the heavily loaded single axle (steering axle).

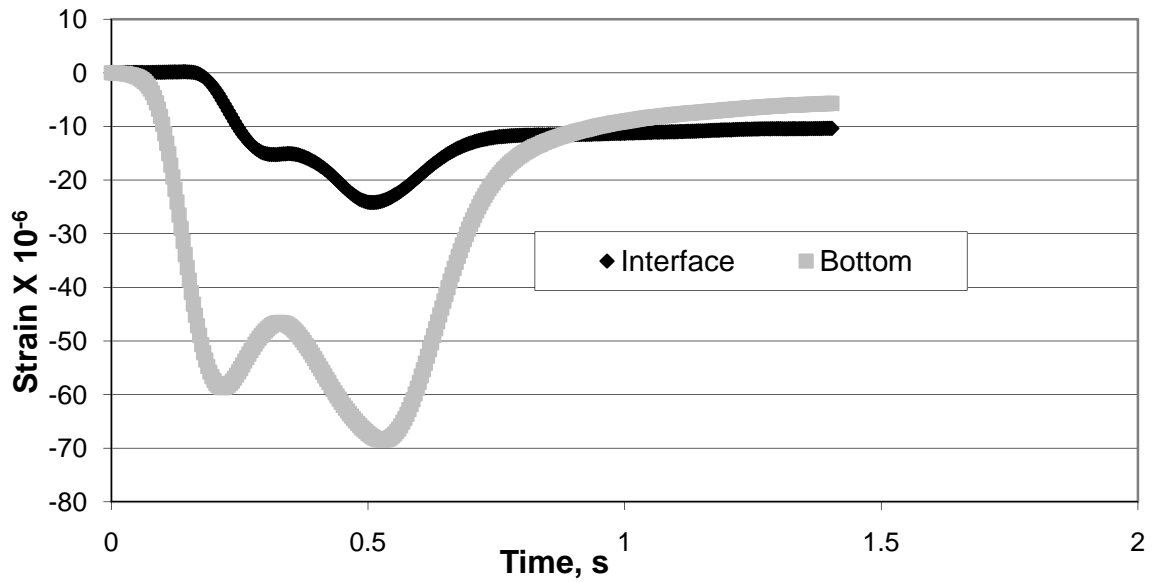
**Test Truck - Wheels Down - Run 2
7/26/2005 - 26 mph - 6" Right**

Figure 12: Strain Measurement from Truck Run 2 – July 2005

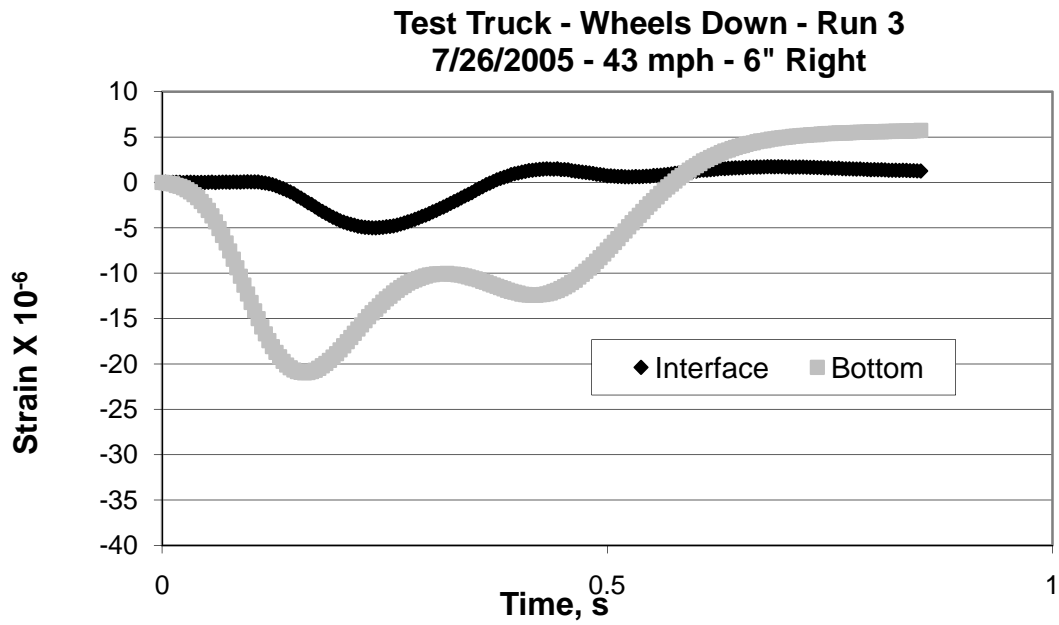
Figure 13: Strain Measurement from Truck Run 3 – July 2005

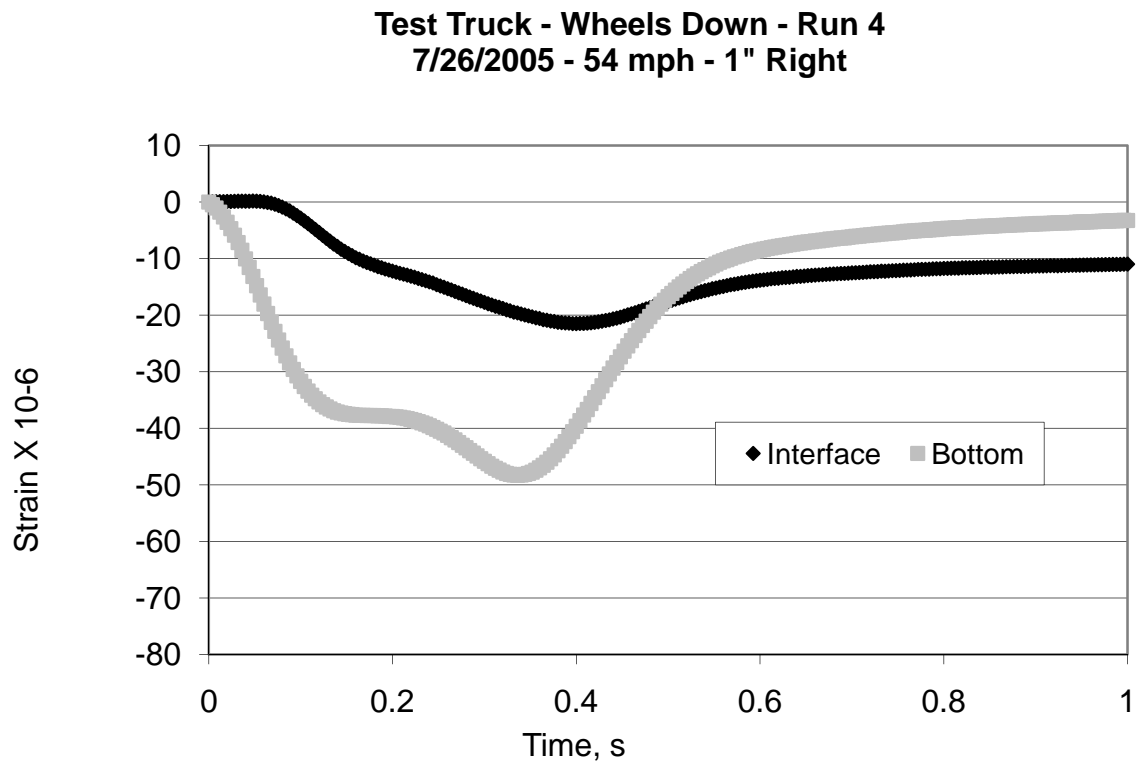
Figure 14: Strain Measurement from Truck Run 4 – July 2005

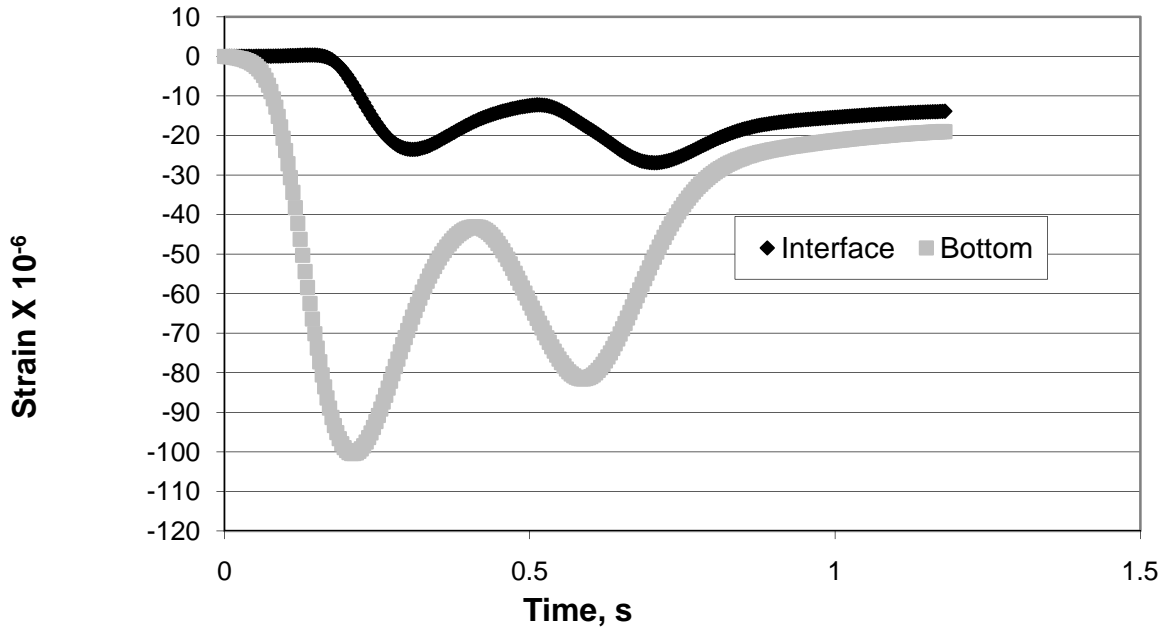
**Test Truck - Wheels Up - Run 1
7/26/2005 - 32 mph - 2" Left**

Figure 15: Strain Measurement from Truck Run 5 – July 2005

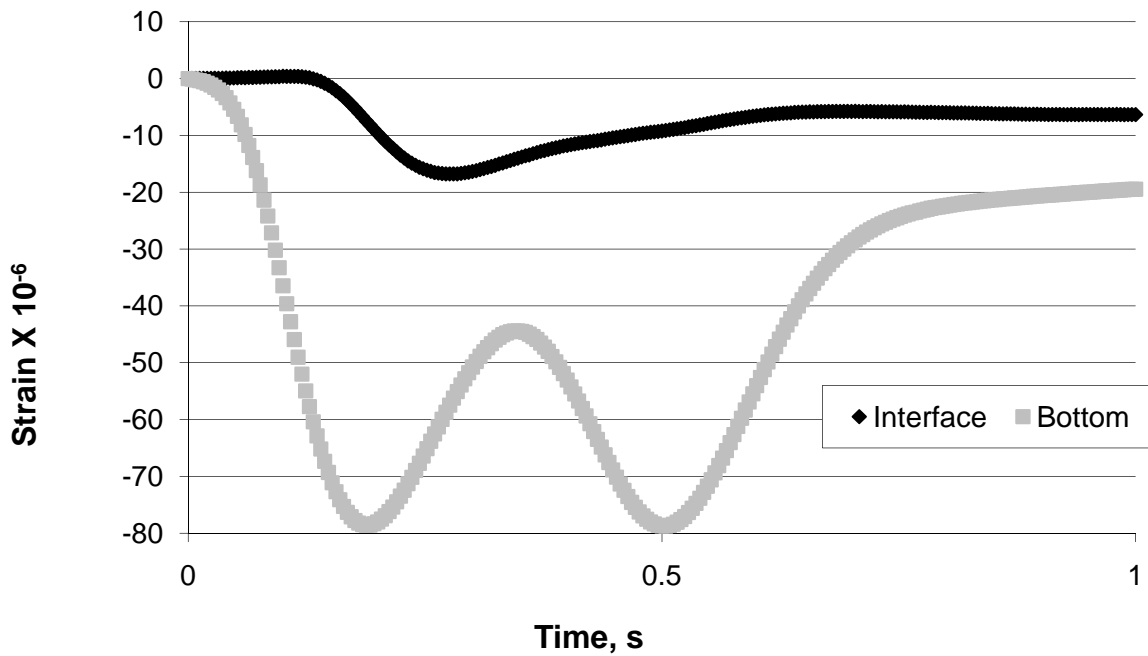
**Test Truck - Wheels Up - Run 2
7/26/2005 - 39 mph - 5" Right**

Figure 16: Strain Measurement from Truck Run 6 – July 2005

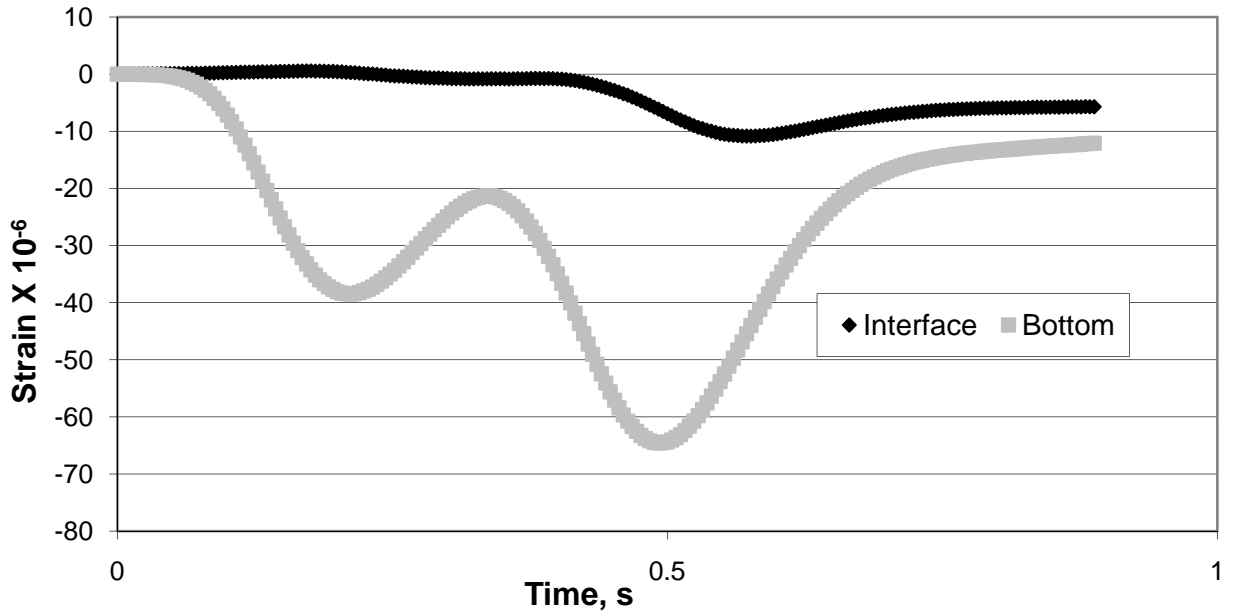
**Test Truck - Wheels Up - Run 3
Kenosha 7/26/2005 - Speed Unknown - 13" Right**

Figure 17: Strain Measurement from Truck Run 7 – July 2005

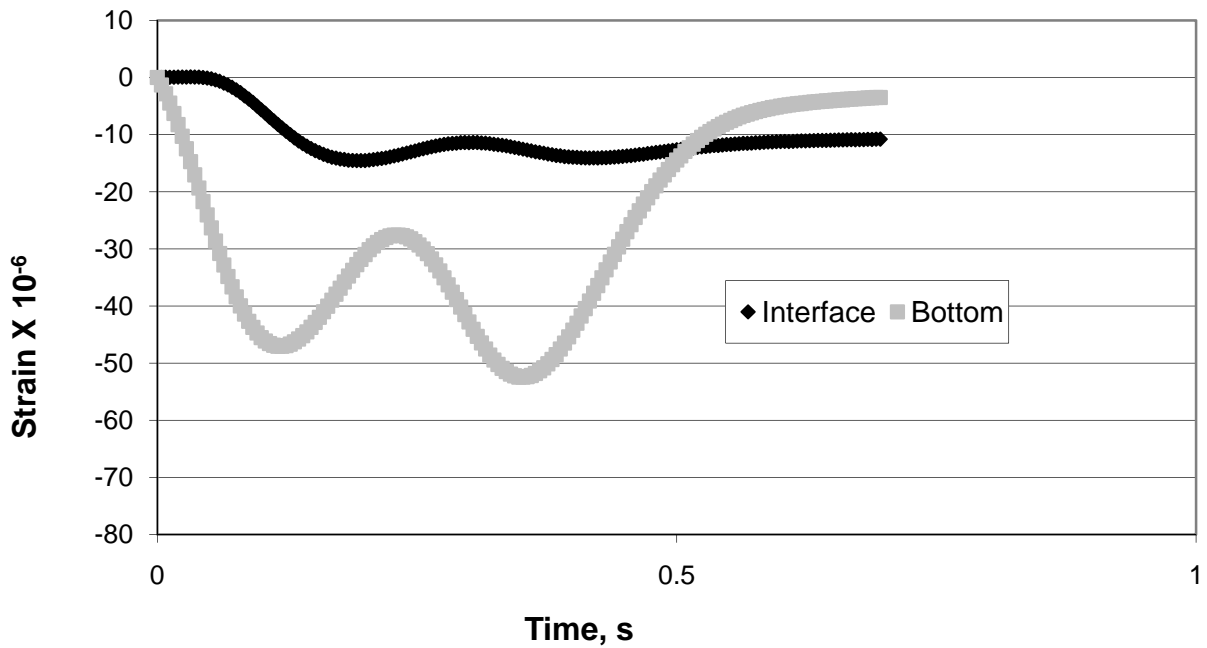
**Test Truck - Wheels Up - Run 4
Kenosha 7/26/2005 - 52 mph - 8" Right**

Figure 18: Strain Measurement from Truck Run 8 – July 2005

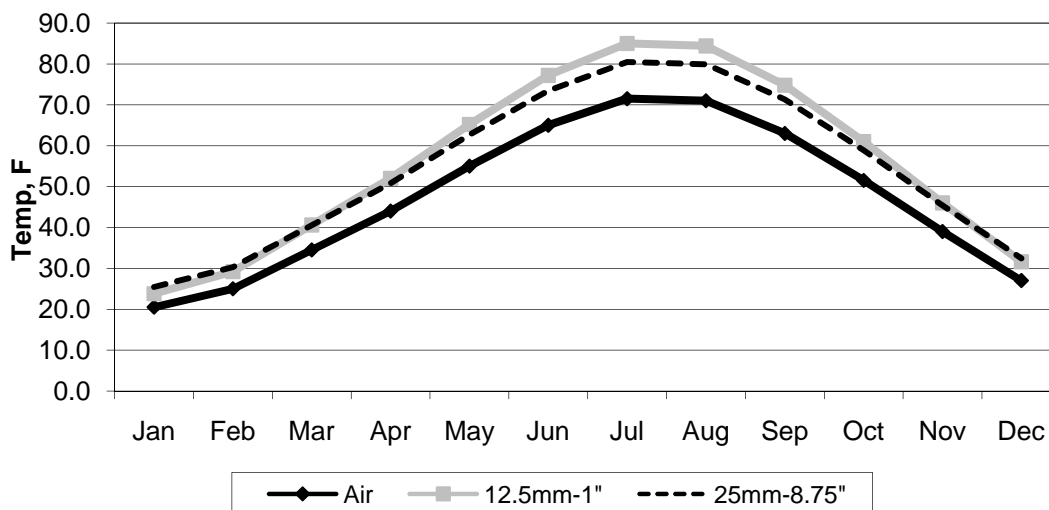
Figure 19: Mean Monthly Temperature Variations for Kenosha, WI

Figure 19 illustrates the variations in MMAT and MMPT established for Kenosha, WI.

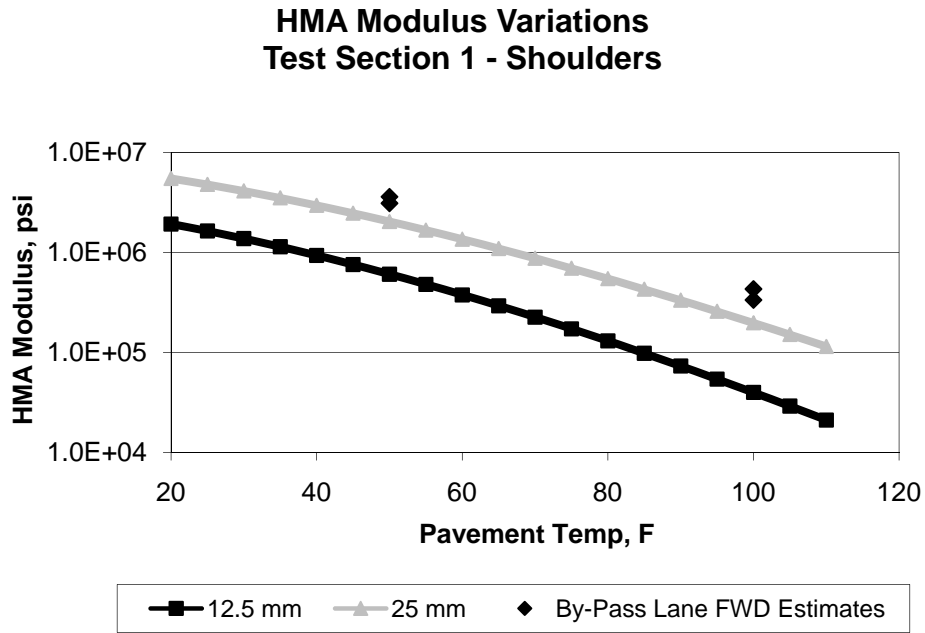
Figure 20: Predicted HMA Moduli Variations for Test Section 1 Shoulders

Equations for predicting the resilient HMA modulus versus NMAS, pavement temperature, % voids and % AC were developed during WHRP Project 0092-03-14 for the HMA shoulder layers used at the Kenosha facility. Figures 20 and 21 illustrate the trends in predicted HMA modulus versus pavement temperature based on the in-place % air voids and design % AC for the HMA shoulder in each test section. Also shown on Figure 20 are the FWD estimates of the by-pass lane combined E_{AC} layer values backcalculated from deflection data obtained during comparative strain measurements. As shown, the combined modulus estimated from the FWD data closely match the 25 mm NMAS E-30X predicted modulus for Test Section 1. The bias of the 25 mm NMAS

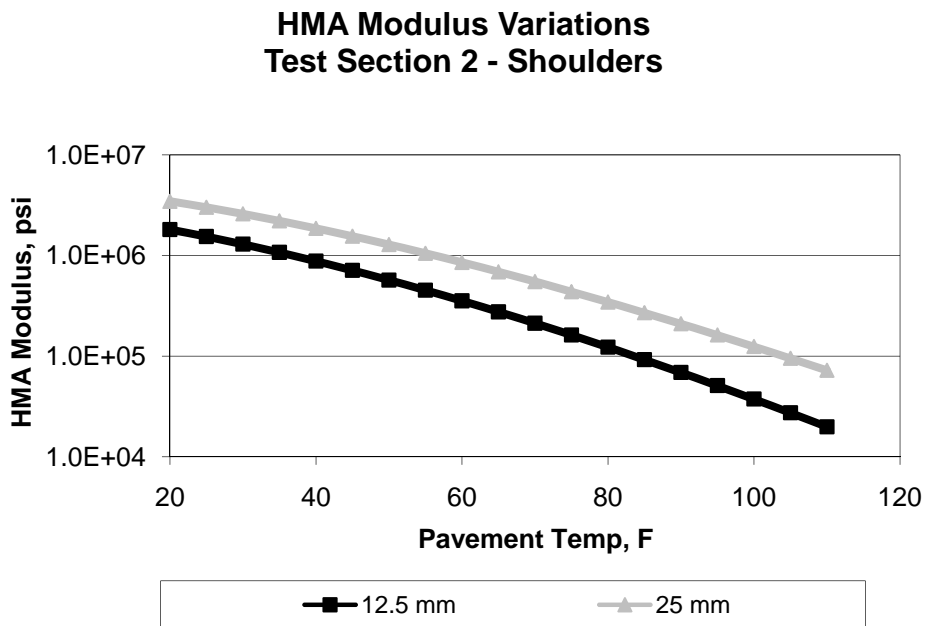
Figure 21: Predicted HMA Moduli Variations for Test Section 2 Shoulders

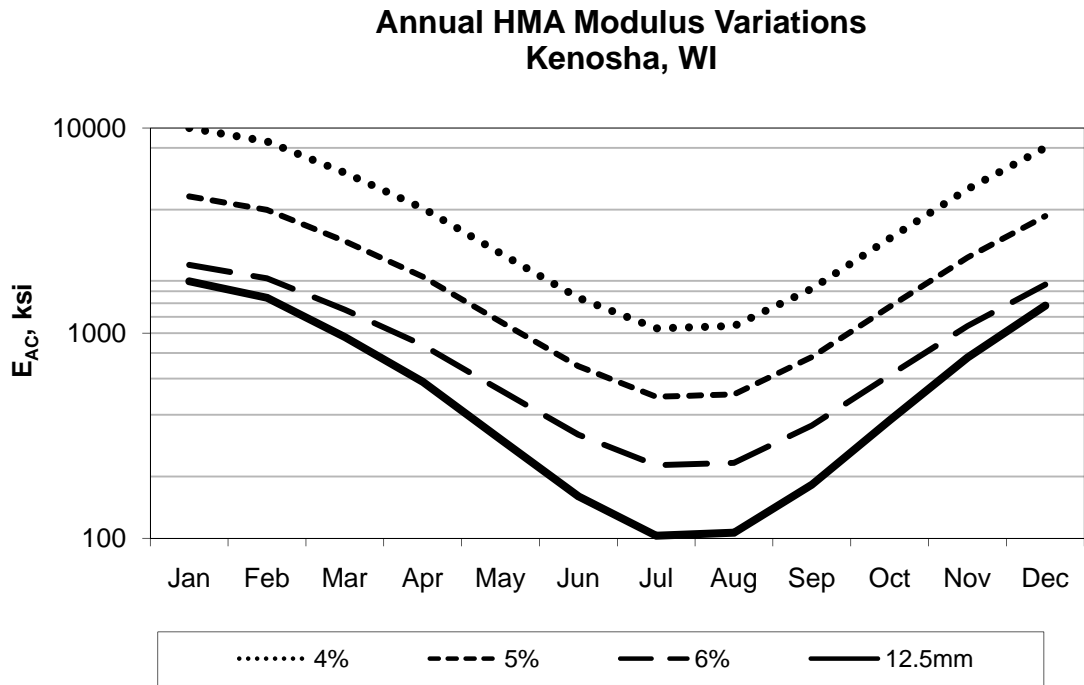
Figure 22: Monthly HMA Moduli Trends for Layer Type

The general trends of HMA modulus versus temperature were combined with the monthly pavement temperature variations typical for Kenosha, WI to develop a trend of average monthly HMA moduli values for the 12.5 mm surface layer at the design values of 6% air voids and for the 25 mm lower layers at air void contents ranging from 4% to 6%, as shown in Figure 22 and Table 6. It should be noted that the average monthly moduli values shown for September are significantly higher than values backcalculated during September 2003 FWD testing (Tables 1–3). This is due to the significant differences in the MMPT = 70°F and the FWD test temperature of 100°F. Conversely, the average monthly moduli values shown for October are less than those backcalculated from FWD testing in October 2003 (Table 4). This is again due to the difference in temperatures (MMPT = 59°F, FWD Test Temp = 50°F).

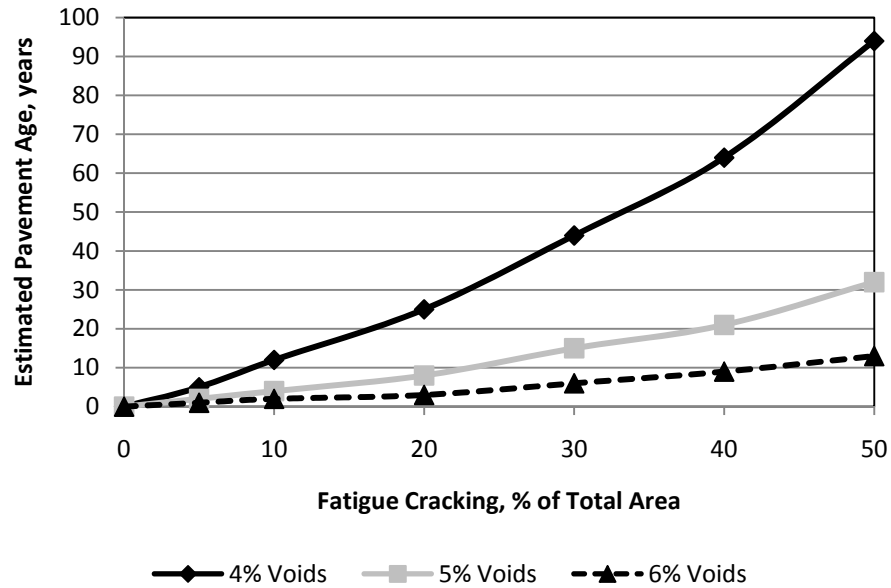
Figure 24: Fatigue Life Estimates Based on Lower Layer Air Void Content

The expected yearly damage is computed as the simple summation of the expected monthly damage values. An estimate of the pavement fatigue life can be computed as the inverse of the yearly damage (decimal value). Table 8 provides the outputs of the HMA fatigue cracking analysis conducted for the range of 4% - 6% air voids within the lower 25mm layers. As shown, the cumulative yearly damages estimated increase significantly as the void content increases. These damage values can be used to estimate the service lives to varying levels of bottom-up fatigue cracking, as shown in Table 9 and Figure 24. As indicated, the estimated fatigue life of the pavement sections is significantly reduced as air voids are increased.
